General Information

Make	Toyota	Model	Vios
YOM	2025	Odo Meter Reading	25,984
Registration No.	CCG4369	Chassis No.	PA1B18F34R4270669
CC	1.3	Transmission	CVT
Fuel Type	Gas	Type of Body	Sedan
Colour	Silver

Body / Panel Condition

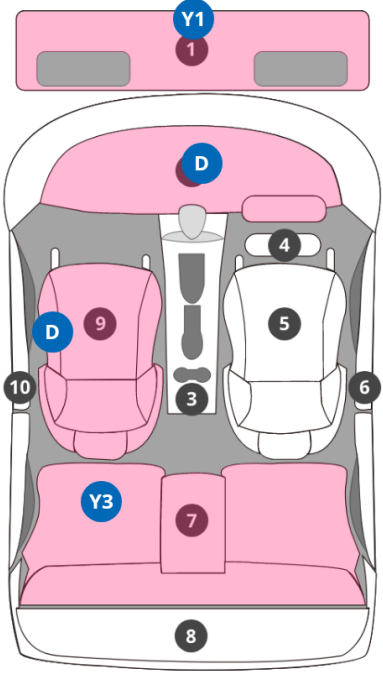
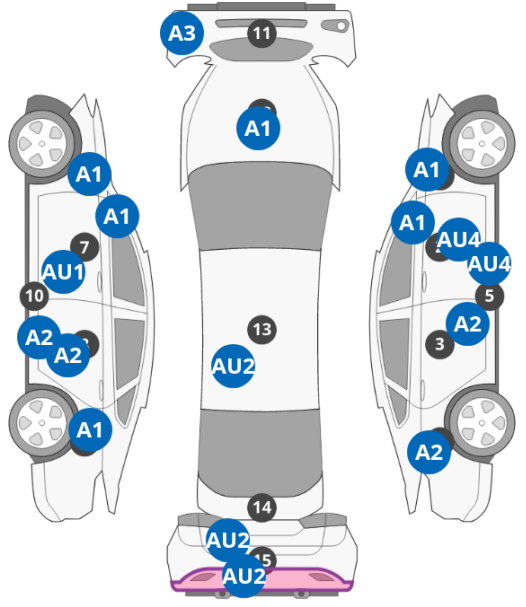
Interior Evaluation :	B	Exterior Evaluation :	D

<p>a : Cut, Fray d : Loose, Deformed k : Animal Hair s : Smell t : Cigarette Burns x : Defective y : Stain</p>		<p>A : Scratch AU : Scratch & Dent B : Modified C : Corrosion G : Stone chip P : Faded S : Rust SC : Rust & Corrosion U : Dent X : Defective Y : Crack, Gap</p>	
<p>Remarks (L) Front Seat - Worn - Yes / Dashboard - Traces of Adhesive Tape - Yes / Ceiling - Grime - Minimal / Rear Seat - Grime - Medium</p>		<p>Remarks (R) Step, In-panel, Side Spoiler - Scratch & Dent - Large / (R) Front Door, Molding - Scratch & Dent - Large / (R) Mirror - Scratch - Minimal / (R) Front Fender, Molding - Scratch - Minimal / (R) Rear Door, Molding - Scratch - Small / (R) Rear Fender, Molding - Scratch - Small / Rear Bumper, Lamps, Panels - Repair mark - Yes / Rear Bumper, Lamps, Panels - Scratch & Dent - Small / Trunk Hood, Rear Gate - Scratch & Dent - Small / (L) Rear Fender, Molding - Scratch - Minimal / (L) Rear Door, Molding - Scratch - Small / Roof - Scratch & Dent - Small / (L) Front Door, Molding - Scratch & Dent - Minimal / (L) Step, In-panel, Side Spoiler - Scratch - Small / (L) Mirror - Scratch - Minimal / (L) Front Fender, Molding - Scratch - Minimal / Bonnet, Headlight - Scratch - Minimal / Front Bumper, Grille, Lamps - Scratch - Medium</p>
