General Information

Make	Toyota	Model	Vios
YOM	2025	Odo Meter Reading	9,209
Registration No.	CCG6970	Chassis No.	PA1B18F36R4276702
CC	1.3	Transmission	CVT
Fuel Type	Gas	Type of Body	Sedan
Colour	Silver

Body / Panel Condition

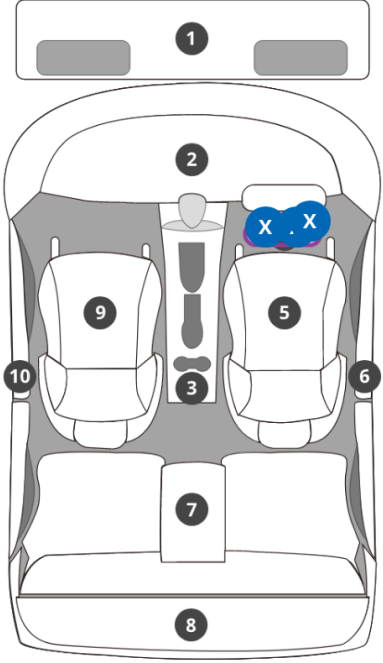
Interior Evaluation : B	Exterior Evaluation : B

<p>a : Cut, Fray d : Loose, Deformed k : Animal Hair s : Smell t : Cigarette Burns x : Defective y : Stain</p>

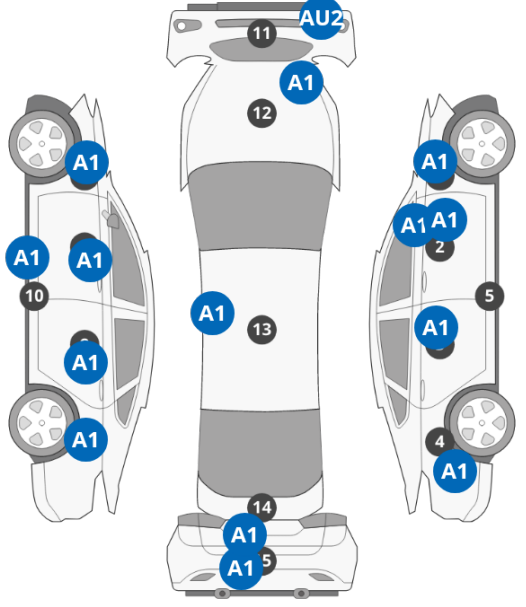
<p>A : Scratch AU : Scratch & Dent B : Modified C : Corrosion G : Stone chip P : Faded S : Rust SC : Rust & Corrosion U : Dent X : Defective Y : Crack, Gap</p>
<p>Remarks (R) Front Floor Mat - Missing - Yes / (L) Front Floor Mat - Missing - Yes / Mat Other - Missing - Yes</p>	<p>Remarks (R) Front Fender - Repair Traces - Yes / Bonnet - Repair Traces - Yes / (L) Front Fender - Repair Traces - Yes / (L) Rear Fender - Repair Traces - Yes / Trunk Hood, Rear Gate - Repair Traces - Yes / (R) Front Fender, Molding - Scratch - Minimal / (R) Mirror - Scratch - Minimal / (R) Front Door, Molding - Scratch - Minimal / (R) Rear Door, Molding - Scratch - Minimal / (R) Rear Fender, Molding - Scratch - Minimal / Rear Bumper, Lamps, Panels - Scratch - Minimal / Trunk Hood, Rear Gate - Scratch - Minimal / (L) Rear Fender, Molding - Scratch - Minimal / (L) Rear Door, Molding - Scratch - Minimal / (L) Step, In-panel, Side Spoiler - Scratch - Minimal / (L) Front Door, Molding - Scratch - Minimal / (L) Front Fender, Molding - Scratch - Minimal / Front Bumper, Grille, Lamps - Scratch & Dent - Small / Bonnet, Headlight - Scratch - Minimal / Roof - Scratch - Minimal</p>

<p>Inspector Notes</p>
<p>With Lto plate, with jack and tools, 1key, no warranty booklet, no spare tire, stain on R fender,scratches on headlights and taillights</p>
