General Information

Make	Toyota	Model	Vios
YOM	2024	Odo Meter Reading	23,671
Registration No.	CAZ8028	Chassis No.	PA1B18F37P4234276
CC	1.3	Transmission	CVT
Fuel Type	Gas	Type of Body	Sedan
Colour	Silver

Body / Panel Condition

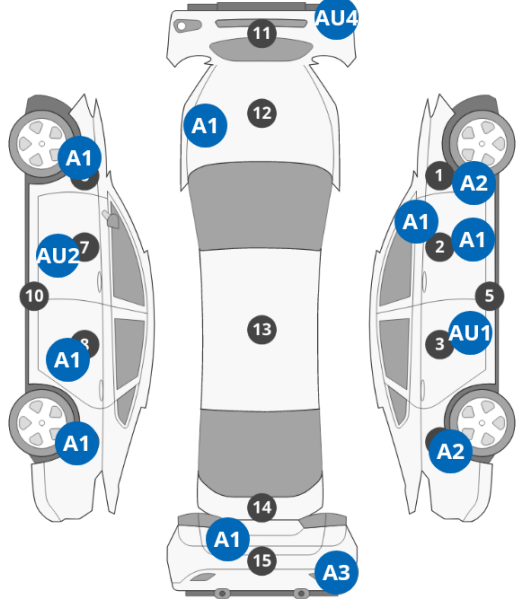
<p>A : Scratch AU : Scratch & Dent B : Modified C : Corrosion G : Stone chip P : Faded S : Rust SC : Rust & Corrosion U : Dent X : Defective Y : Crack, Gap</p>
Remarks Defects not found	Remarks (R) Front Fender, Molding - Scratch - Small / (R) Mirror - Scratch - Minimal / (R) Front Door, Molding - Scratch - Minimal / (R) Rear Door, Molding - Scratch & Dent - Minimal / (R) Rear Fender, Molding - Scratch - Small / Rear Bumper, Lamps, Panels - Scratch - Medium / Trunk Hood, Rear Gate - Scratch - Minimal / (L) Rear Fender, Molding - Scratch - Minimal / (L) Rear Door, Molding - Scratch - Minimal / (L) Front Door, Molding - Scratch & Dent - Small / (L) Front Fender, Molding - Scratch - Minimal / Front Bumper, Grille, Lamps - Scratch & Dent - Large / Bonnet, Headlight - Scratch - Minimal

Inspector Notes
With Lto plate, with warranty booklet, with spare tire and jack, 1key, no tools, scratches on headlights and taillights
