General Information

Make	Toyota	Model	Vios
YOM	2025	Odo Meter Reading	11,062
Registration No.	CCG4560	Chassis No.	PA1B18F34R4269926
CC	1.3	Transmission	CVT
Fuel Type	Gas	Type of Body	Sedan
Colour	Black

Body / Panel Condition

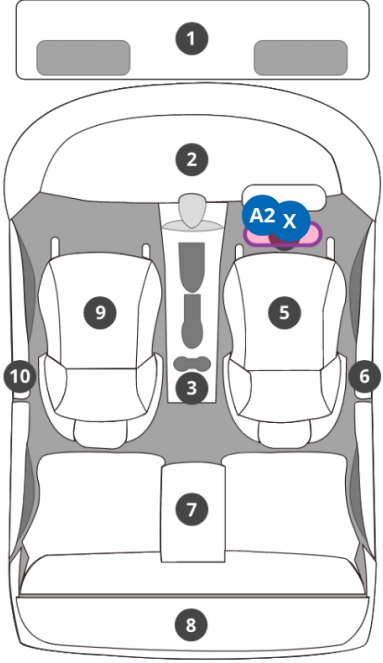
Interior Evaluation : B	Exterior Evaluation : B

<p>a : Cut, Fray d : Loose, Deformed k : Animal Hair s : Smell t : Cigarette Burns x : Defective y : Stain</p>

<p>A : Scratch AU : Scratch & Dent B : Modified C : Corrosion G : Stone chip P : Faded S : Rust SC : Rust & Corrosion U : Dent X : Defective Y : Crack, Gap</p>
<p>Remarks (R) Front Floor Mat - Missing - Yes / (L) Front Floor Mat - Cut, Crack - Small</p>	<p>Remarks (R) Front Fender, Molding - Scratch - Medium / (R) Front Door, Molding - Scratch - Minimal / (R) Rear Door, Molding - Scratch & Dent - Minimal / (R) Rear Fender, Molding - Scratch - Medium / Rear Bumper, Lamps, Panels - Scratch - Minimal / Trunk Hood, Rear Gate - Scratch - Minimal / (L) Rear Fender, Molding - Scratch & Dent - Minimal / (L) Rear Door, Molding - Scratch & Dent - Small / (L) Front Door, Molding - Scratch & Dent - Minimal / (L) Front Fender, Molding - Scratch - Minimal / Bonnet, Headlight - Scratch - Minimal / Front Bumper, Grille, Lamps - Scratch - Small / Roof - Scratch - Minimal</p>

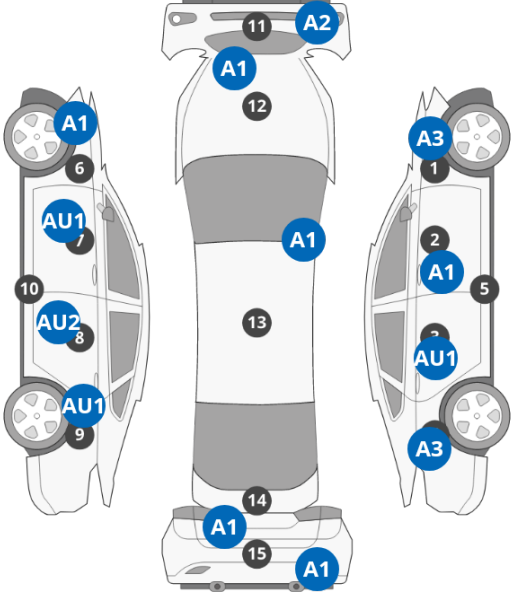
<p>Inspector Notes</p>
<p>With Lto plate, with warranty booklet, with spare tire and jack, 1key, no tools, scratches on headlights,</p>
