General Information

Make	Toyota	Model	Vios
YOM	2025	Odo Meter Reading	60,866
Registration No.	NKI9656	Chassis No.	PA1B18F30R4261365
CC	1.3	Transmission	CVT
Fuel Type	Gas	Type of Body	Sedan
Colour	Blue

Body / Panel Condition

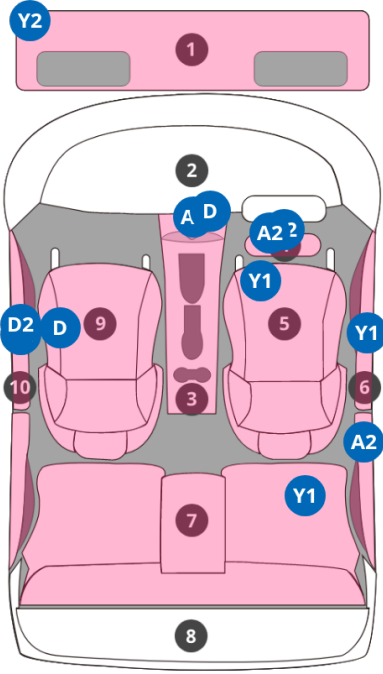
Interior Evaluation : C	Exterior Evaluation : E

<p>a : Cut, Fray d : Loose, Deformed k : Animal Hair s : Smell t : Cigarette Burns x : Defective y : Stain</p>

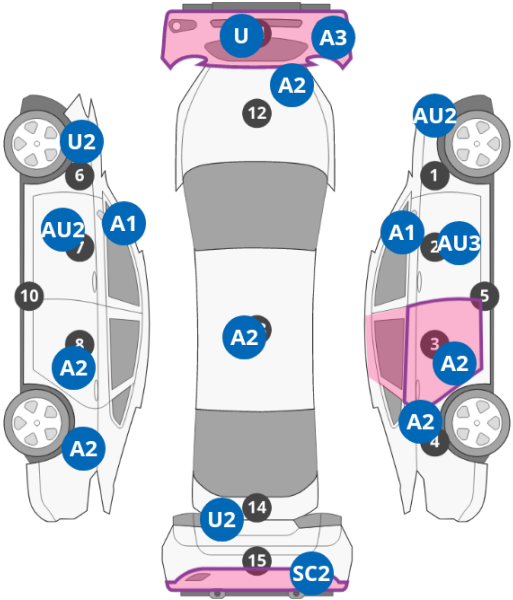
<p>A : Scratch AU : Scratch & Dent B : Modified C : Corrosion G : Stone chip P : Faded S : Rust SC : Rust & Corrosion U : Dent X : Defective Y : Crack, Gap</p>
<p>Remarks (L) Front Seat - Worn - Yes / Console, Switches, Vents - Worn, Scratch, Cut, Crack - Small / Console, Switches, Vents - Traces of Adhesive Tape - Yes / (R) Front Trim - Grime - Minimal / (L) Front Trim - Grime - Small / (L) Front Trim - Worked - Small / (L) Front Floor Mat - Worked - Small / (L) Front Floor Mat - Cut, Crack - Small / (R) Rear Trim - Cut, Crack - Small / Rear Seat - Grime - Minimal / Ceiling - Grime - Small / (R) Front Seat - Grime - Minimal</p>	<p>Remarks (R) Front Fender - Repair Traces - Yes / (L) Front Fender - Repair Traces - Yes / Front Bumper, Grille, Lamps - Repair mark - Yes / (R) Front Fender, Molding - Scratch & Dent - Small / (R) Mirror - Scratch - Minimal / Member (Bolted) - Dent - Yes / (R) Front Door, Molding - Scratch & Dent - Medium / (R) Rear Door, Molding - Repair mark - Yes / (R) Rear Door, Molding - Scratch - Small / (R) Rear Fender, Molding - Scratch - Small / Rear Bumper, Lamps, Panels - Repair mark - Yes / Rear Bumper, Lamps, Panels - Rust, Corrosion - Small / Trunk Hood, Rear Gate - Dent - Small / (L) Rear Fender, Molding - Scratch - Small / (L) Rear Door, Molding - Scratch - Small / (L) Front Door, Molding - Scratch & Dent - Small / (L) Mirror - Scratch - Minimal / (L) Front Fender, Molding - Dent - Small / Front Bumper, Grille, Lamps - Scratch - Medium / Bonnet, Headlight - Scratch - Small / Roof - Scratch - Small</p>
