## General Information

<b>Make</b>	Toyota	<b>Model</b>	Vios
<b>YOM</b>	2025	<b>Odo Meter Reading</b>	18,691
<b>Registration No.</b>	CCG6490	<b>Chassis No.</b>	PA1B18F31R4276171
<b>CC</b>	1.3	<b>Transmission</b>	CVT
<b>Fuel Type</b>	Gas	<b>Type of Body</b>	Sedan
<b>Colour</b>	Red

## Body / Panel Condition

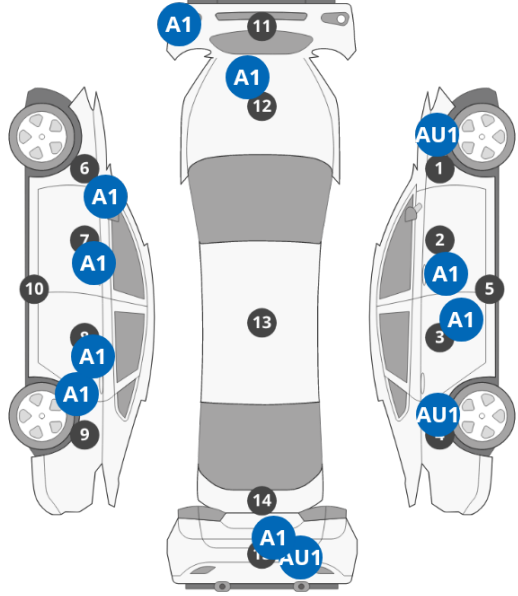
<p><b>A</b> : Scratch <b>AU</b> : Scratch &amp; Dent <b>B</b> : Modified <b>C</b> : Corrosion <b>G</b> : Stone chip <b>P</b> : Faded <b>S</b> : Rust <b>SC</b> : Rust &amp; Corrosion <b>U</b> : Dent <b>X</b> : Defective <b>Y</b> : Crack, Gap</p>
<p><b>Remarks</b> Defects not found</p>	<p><b>Remarks</b> (R) Front Fender, Molding - Scratch &amp; Dent - Minimal / (R) Front Door, Molding - Scratch - Minimal / (R) Rear Door, Molding - Scratch - Minimal / (R) Rear Fender, Molding - Scratch &amp; Dent - Minimal / Rear Bumper, Lamps, Panels - Scratch &amp; Dent - Minimal / Trunk Hood, Rear Gate - Scratch - Minimal / (L) Rear Fender, Molding - Scratch - Minimal / (L) Rear Door, Molding - Scratch - Minimal / (L) Front Door, Molding - Scratch - Minimal / (L) Mirror - Scratch - Minimal / Bonnet, Headlight - Scratch - Minimal / Front Bumper, Grille, Lamps - Scratch - Minimal</p>
