General Information

Make	Toyota	Model	Wigo
YOM	2025	Odo Meter Reading	9,621
Registration No.	DCA5891	Chassis No.	MHKAA1BC1RJ030698
CC	1.0	Transmission	CVT
Fuel Type	Gas	Type of Body	Hatchback
Colour	Orange

Body / Panel Condition

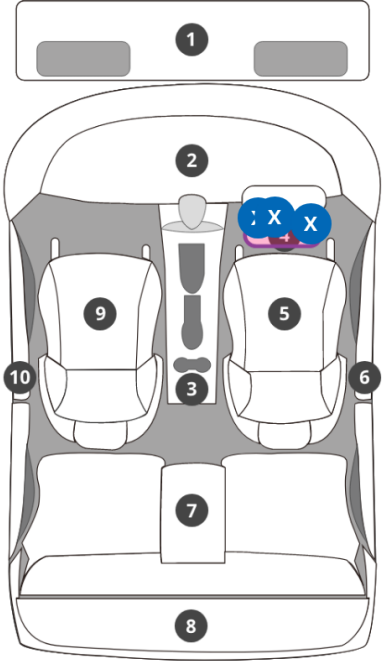
Interior Evaluation : B	Exterior Evaluation : D

<p>a : Cut, Fray d : Loose, Deformed k : Animal Hair s : Smell t : Cigarette Burns x : Defective y : Stain</p>

<p>A : Scratch AU : Scratch & Dent B : Modified C : Corrosion G : Stone chip P : Faded S : Rust SC : Rust & Corrosion U : Dent X : Defective Y : Crack, Gap</p>
<p>Remarks (R) Front Floor Mat - Missing - Yes / (L) Front Floor Mat - Missing - Yes / Mat Other - Missing - Yes</p>	<p>Remarks (R) Front Fender, Molding - Scratch - Minimal / (R) Mirror - Scratch - Minimal / (R) Front Door, Molding - Scratch - Medium / (R) Rear Door, Molding - Scratch & Dent - Small / (R) Step, In-panel, Side Spoiler - Scratch - Minimal / (R) Rear Fender, Molding - Scratch - Minimal / Rear Bumper, Lamps, Panels - Scratch & Dent - Small / Trunk Hood, Rear Gate - Scratch & Dent - Medium / (L) Rear Fender, Molding - Scratch & Dent - Small / (L) Rear Door, Molding - Scratch & Dent - Medium / (L) Front Door, Molding - Scratch - Minimal / Front Bumper, Grille, Lamps - Scratch & Dent - Large / Bonnet, Headlight - Scratch & Dent - Small / (L) Front Fender, Molding - Crack, Gap - Small</p>

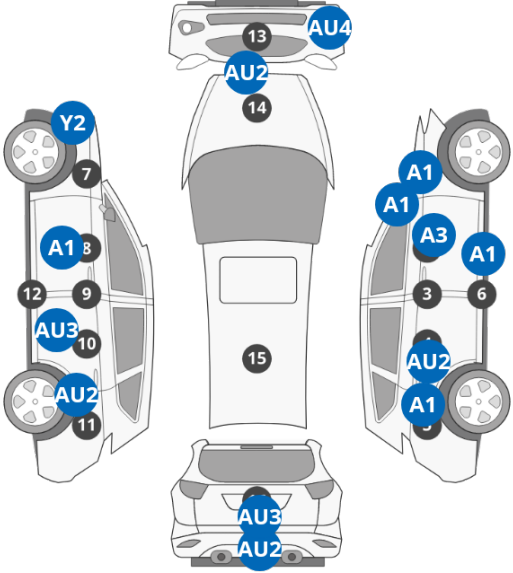
<p>Inspector Notes</p>
<p>With Lto plate, with spare tire and jack, 2keys, no warranty booklet and tools, Crack headlight and fog light,scratches on taillights</p>
