General Information

Make	Toyota	Model	Yaris Cross
YOM	2024	Odo Meter Reading	37,830
Registration No.	IAF3347	Chassis No.	MHFAABAF6P0017449
CC	1.5	Transmission	CVT
Fuel Type	Gas	Type of Body	SUV
Colour	White

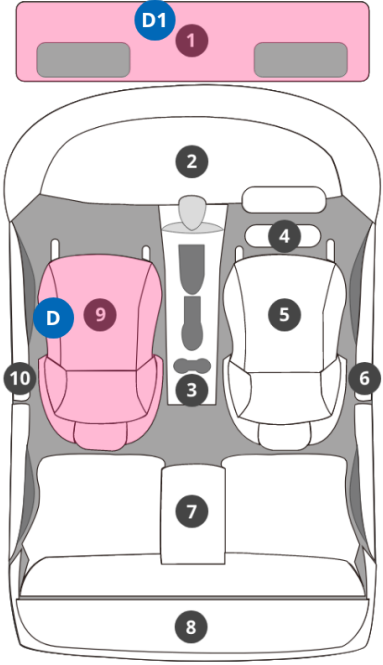
Interior Evaluation : B	Exterior Evaluation : C

<p>a : Cut, Fray d : Loose, Deformed k : Animal Hair s : Smell t : Cigarette Burns x : Defective y : Stain</p>

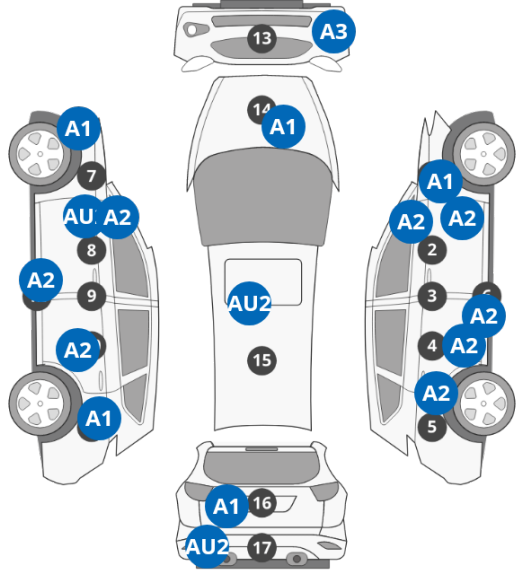
<p>A : Scratch AU : Scratch & Dent B : Modified C : Corrosion G : Stone chip P : Faded S : Rust SC : Rust & Corrosion U : Dent X : Defective Y : Crack, Gap</p>
Remarks (L) Front Seat - Worn - Yes / Ceiling - Crinkle - Minimal	Remarks (L) Front Fender - Repair Traces - Yes / (R) Mirror - Scratch - Small / (R) Front Fender, Molding - Scratch - Minimal / (R) Step, In-panel, Side Spoiler - Scratch - Small / (R) Front Door, Molding - Scratch - Small / (R) Rear Door, Molding - Scratch - Small / (R) Rear Fender, Molding - Scratch - Small / Rear Bumper, Lamps, Panels - Scratch & Dent - Small / Trunk Hood, Rear Gate - Scratch - Minimal / (L) Rear Fender, Molding - Scratch - Minimal / (L) Front Door, Molding - Scratch & Dent - Small / (L) Rear Door, Molding - Scratch - Small / (L) Step, In-panel, Side Spoiler - Scratch - Small / (L) Mirror - Scratch - Small / (L) Front Fender, Molding - Scratch - Minimal / Front Bumper, Grille, Lamps - Scratch - Medium / Bonnet, Headlight - Scratch - Minimal / Roof - Scratch & Dent - Small
