General Information

Body / Panel Condition

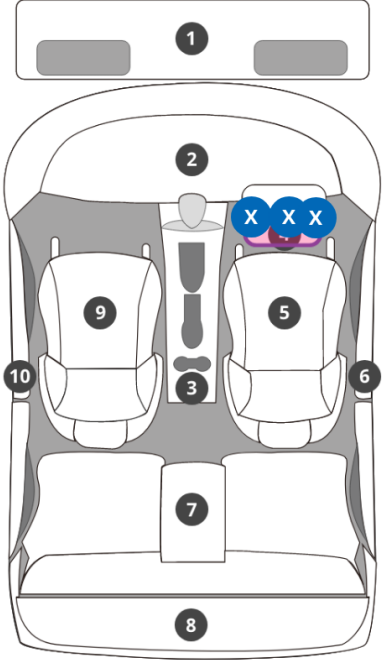
Interior Evaluation : B	Exterior Evaluation : C

<p>a : Cut, Fray d : Loose, Deformed k : Animal Hair s : Smell t : Cigarette Burns x : Defective y : Stain</p>

<p>A : Scratch AU : Scratch & Dent B : Modified C : Corrosion G : Stone chip P : Faded S : Rust SC : Rust & Corrosion U : Dent X : Defective Y : Crack, Gap</p>
<p>Remarks (R) Front Floor Mat - Missing - Yes / (L) Front Floor Mat - Missing - Yes / Mat Other - Missing - Yes</p>	<p>Remarks (R) Front Fender, Molding - Scratch - Minimal / (R) Mirror - Scratch - Minimal / (R) Front Door, Molding - Scratch - Minimal / (R) Rear Door, Molding - Scratch - Minimal / (R) Step, In-panel, Side Spoiler - Scratch - Minimal / (R) Rear Fender, Molding - Scratch - Minimal / Trunk Hood, Rear Gate - Scratch - Minimal / Rear Bumper, Lamps, Panels - Scratch - Small / (L) Rear Fender, Molding - Scratch - Minimal / (L) Rear Door, Molding - Scratch - Minimal / (L) Step, In-panel, Side Spoiler - Scratch - Minimal / (L) Front Door, Molding - Scratch - Minimal / (L) Front Fender, Molding - Scratch - Minimal / Bonnet, Headlight - Scratch - Minimal / Front Bumper, Grille, Lamps - Scratch & Dent - Large / Roof - Scratch - Minimal</p>

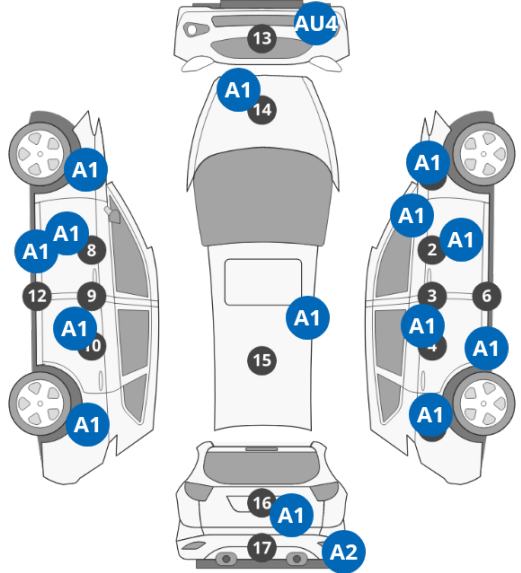
<p>Inspector Notes</p>
<p>With Lto plate, with warranty booklet, 2keys, with spare tire and jack, no tools,cover under the engine missing, moisture inside front headlight, scratches on headlights and taillights</p>
