General Information

Make	Suzuki	Model	Carry
YOM	2025	Odo Meter Reading	22,868
Registration No.	NKG1887	Chassis No.	MHYD61T5SJ212132
CC	1.5	Transmission	M/T
Fuel Type	Gas	Type of Body	Utility Vehicle
Colour	White

Body / Panel Condition

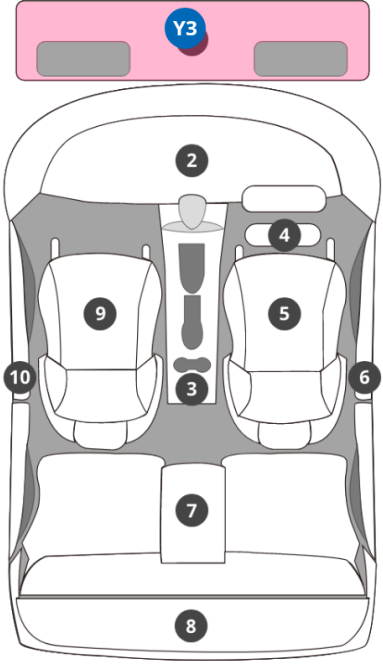
Interior Evaluation : B	Exterior Evaluation : E

<p>a : Cut, Fray d : Loose, Deformed k : Animal Hair s : Smell t : Cigarette Burns x : Defective y : Stain</p>

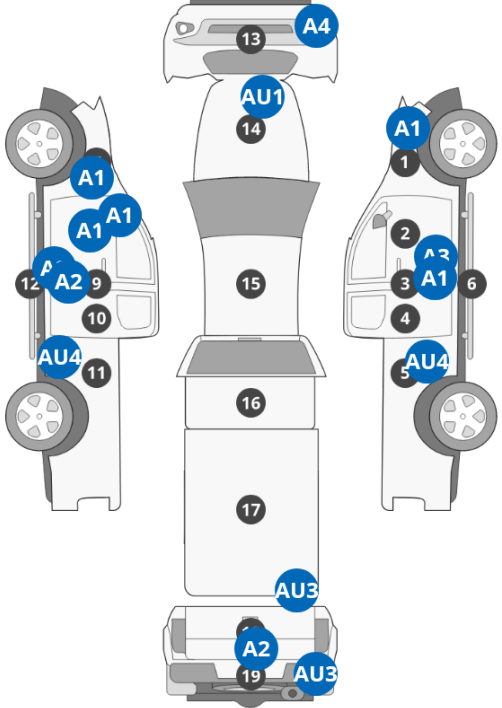
<p>A : Scratch AU : Scratch & Dent B : Modified C : Corrosion G : Stone chip P : Faded S : Rust SC : Rust & Corrosion U : Dent X : Defective Y : Crack, Gap</p>
Remarks Ceiling - Grime - Medium	Remarks (R) Rear Corner Panel - Repair Traces - Yes / (R) Front Fender, Molding - Scratch - Minimal / (R) Front Door, Molding - Scratch - Medium / (R) Center Panel - Scratch - Minimal / (R) Side Gate - Scratch & Dent - Large / Rear Bumper, Lamps, Panels - Scratch & Dent - Medium / Roof - Scratch & Dent - Medium / Rear Gate - Scratch - Small / (L) Side Gate - Scratch & Dent - Large / (L) Step, In-panel, Side Spoiler - Scratch - Small / (L) Center Panel - Scratch - Small / (L) Front Door, Molding - Scratch - Minimal / (L) Front Fender, Molding - Scratch - Minimal / Front Bumper, Grille, Lamps - Scratch - Large / Front Panel - Scratch & Dent - Minimal / (L) Mirror - Scratch - Minimal

Inspector Notes
With Lto plate, with spare tire, 2keys, no warranty booklet, no jack and tools, scratches on headlights and taillights
