General Information

Make	Toyota	Model	Wigo
YOM	2023	Odo Meter Reading	29,686
Registration No.	NIH9936	Chassis No.	MHKADF3FLJ73M462
CC	1.0	Transmission	A/T
Fuel Type	Gas	Type of Body	Sedan
Colour	Orange

Body / Panel Condition

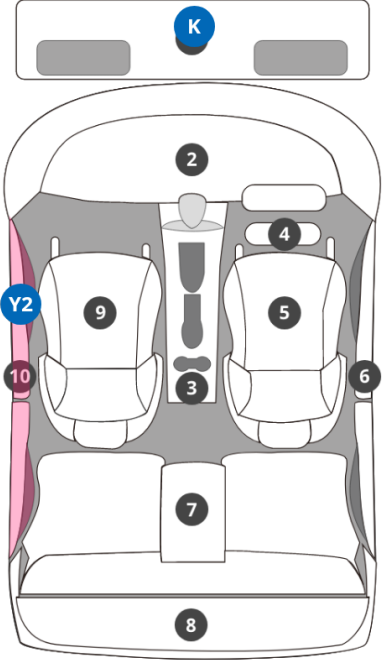
Interior Evaluation : B	Exterior Evaluation : E

<p>a : Cut, Fray d : Loose, Deformed k : Animal Hair s : Smell t : Cigarette Burns x : Defective y : Stain</p>

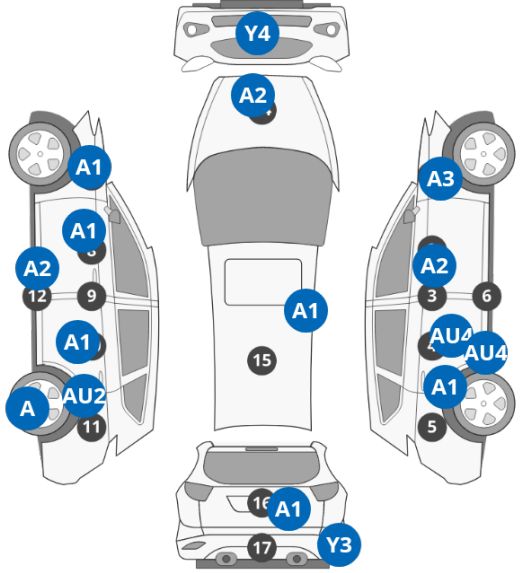
<p>A : Scratch AU : Scratch & Dent B : Modified C : Corrosion G : Stone chip P : Faded S : Rust SC : Rust & Corrosion U : Dent X : Defective Y : Crack, Gap</p>
Remarks (L) Front Trim - Grime - Small / Overall Interior - Animal Hair - Yes	Remarks (R) Front Fender, Molding - Scratch - Medium / (R) Front Door, Molding - Scratch - Small / (R) Rear Door, Molding - Scratch & Dent - Large / (R) Step, In-panel, Side Spoiler - Scratch & Dent - Large / (R) Rear Fender, Molding - Scratch - Minimal / Rear Bumper, Lamps, Panels - Crack, Gap - Medium / Trunk Hood, Rear Gate - Scratch - Minimal / (L) Rear Fender, Molding - Scratch & Dent - Small / (L) Rear Door, Molding - Scratch - Minimal / (L) Step, In-panel, Side Spoiler - Scratch - Small / (L) Front Door, Molding - Scratch - Minimal / (L) Front Fender, Molding - Scratch - Minimal / Front Bumper, Grille, Lamps - Crack, Gap - Large / Bonnet, Headlight - Scratch - Small / Roof - Scratch - Minimal / (L) Rear Tyre - Crack, Cut - Yes
