General Information

Make	Toyota	Model	Veloz
YOM	2023	Odo Meter Reading	34,401
Registration No.	NIG5470	Chassis No.	MHFAB1BY1N3039052
CC	1.5	Transmission	CVT
Fuel Type	Gas	Type of Body	Wagon
Colour	Silver

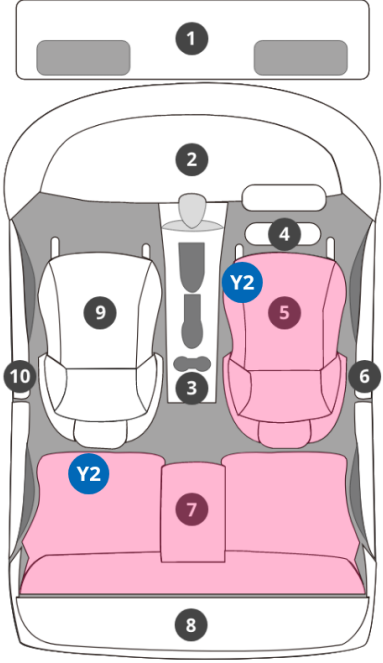
<p>a : Cut, Fray d : Loose, Deformed k : Animal Hair s : Smell t : Cigarette Burns x : Defective y : Stain</p>

<p>A : Scratch AU : Scratch & Dent B : Modified C : Corrosion G : Stone chip P : Faded S : Rust SC : Rust & Corrosion U : Dent X : Defective Y : Crack, Gap</p>
<p>Remarks Rear Seat - Grime - Small / (R) Front Seat - Grime - Small</p>	<p>Remarks (R) Front Door - Repair Traces - Yes / (L) Rear Door - Repair Traces - Yes / (R) Front Fender, Molding - Scratch - Minimal / (R) Front Door, Molding - Repair mark - Difference in Color / (R) Mirror - Scratch - Small / (R) Front Door, Molding - Scratch - Minimal / (R) Rear Door, Molding - Scratch & Dent - Minimal / (R) Step, In-panel, Side Spoiler - Scratch - Small / (R) Rear Fender, Molding - Scratch & Dent - Small / Rear Bumper, Lamps, Panels - Scratch & Dent - Minimal / Trunk Hood, Rear Gate - Scratch - Minimal / Rear Bumper, Lamps, Panels - Repair mark - Difference in Color / (L) Rear Fender, Molding - Repair mark - Difference in Color / (L) Rear Door, Molding - Repair mark - Difference in Color / (L) Rear Fender, Molding - Scratch - Minimal / (L) Rear Door, Molding - Scratch - Small / (L) Front Door, Molding - Scratch - Minimal / (L) Front Fender, Molding - Scratch - Minimal / Front Bumper, Grille, Lamps - Scratch - Minimal / Bonnet, Headlight - Scratch - Minimal / Roof - Scratch - Minimal</p>

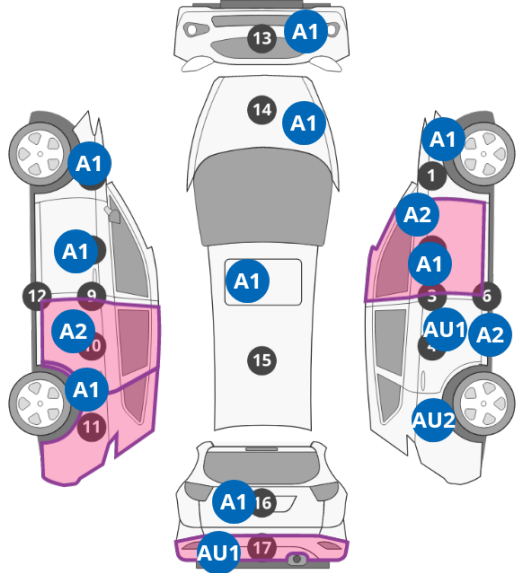
<p>Inspector Notes</p>
<p>With Lto plate, with warranty booklet, with spare tire and jack, 1key, no tools, scratches on headlights and taillights</p>
