General Information

Make	Toyota	Model	Vios
YOM	2020	Odo Meter Reading	66,300
Registration No.	NFX7349	Chassis No.	PA1B18F30L4115401
CC	1.3	Transmission	CVT
Fuel Type	Gas	Type of Body	Sedan
Colour	White

Body / Panel Condition

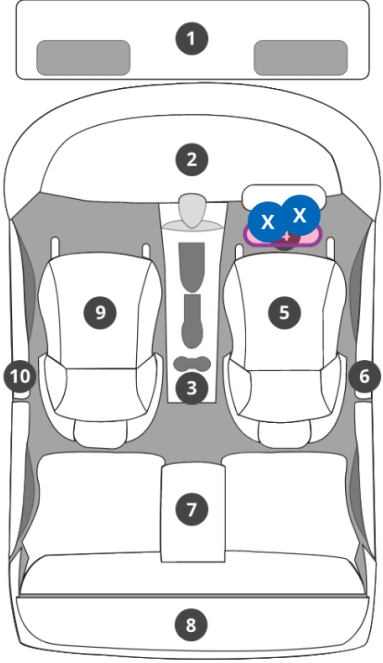
Interior Evaluation : B	Exterior Evaluation : C

<p>a : Cut, Fray d : Loose, Deformed k : Animal Hair s : Smell t : Cigarette Burns x : Defective y : Stain</p>

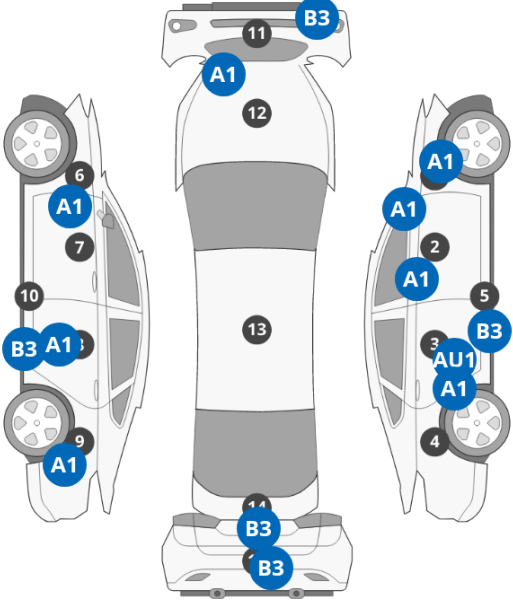
<p>A : Scratch AU : Scratch & Dent B : Modified C : Corrosion G : Stone chip P : Faded S : Rust SC : Rust & Corrosion U : Dent X : Defective Y : Crack, Gap</p>
<p>Remarks (R) Front Floor Mat - Missing - Yes / (L) Front Floor Mat - Missing - Yes</p>	<p>Remarks (R) Front Fender, Molding - Scratch - Minimal / (R) Mirror - Scratch - Minimal / (R) Front Door, Molding - Scratch - Minimal / (R) Rear Door, Molding - Scratch & Dent - Minimal / (R) Rear Fender, Molding - Scratch - Minimal / Rear Bumper, Lamps, Panels - Modified - Medium / (R) Step, In-panel, Side Spoiler - Modified - Medium / (L) Step, In-panel, Side Spoiler - Modified - Medium / Trunk Hood, Rear Gate - Modified - Medium / (L) Rear Fender, Molding - Scratch - Minimal / (L) Rear Door, Molding - Scratch - Minimal / (L) Front Door, Molding - Scratch - Minimal / Bonnet, Headlight - Scratch - Minimal / Front Bumper, Grille, Lamps - Modified - Medium</p>
