General Information

Make	Toyota	Model	Vios
YOM	2025	Odo Meter Reading	29,857
Registration No.	NKK7368	Chassis No.	PA1B18F31R4269222
CC	1.3	Transmission	CVT
Fuel Type	Gas	Type of Body	Sedan
Colour	Blackish Red Mica

Body / Panel Condition

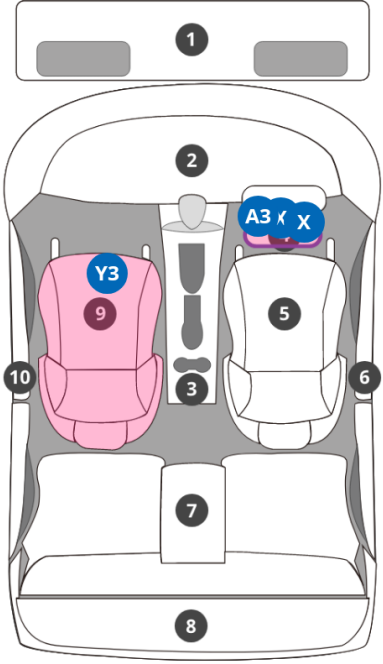
Interior Evaluation : B	Exterior Evaluation : E

<p>a : Cut, Fray d : Loose, Deformed k : Animal Hair s : Smell t : Cigarette Burns x : Defective y : Stain</p>

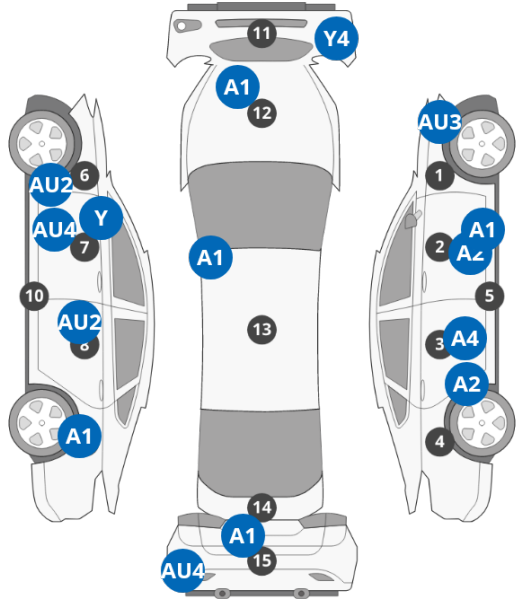
<p>A : Scratch AU : Scratch & Dent B : Modified C : Corrosion G : Stone chip P : Faded S : Rust SC : Rust & Corrosion U : Dent X : Defective Y : Crack, Gap</p>
<p>Remarks (R) Front Floor Mat - Missing - Yes / Mat Other - Missing - Yes / (L) Front Floor Mat - Cut, Crack - Medium / (L) Front Seat - Grime - Medium</p>	<p>Remarks (R) Front Fender, Molding - Scratch & Dent - Medium / (R) Front Door, Molding - Scratch - Small / (R) Step, In-panel, Side Spoiler - Scratch - Minimal / (R) Rear Door, Molding - Scratch - Large / (R) Rear Fender, Molding - Scratch - Small / Rear Bumper, Lamps, Panels - Scratch & Dent - Large / Trunk Hood, Rear Gate - Scratch - Minimal / (L) Rear Fender, Molding - Scratch - Minimal / (L) Rear Door, Molding - Scratch & Dent - Small / (L) Mirror - Crack - Damaged / (L) Front Door, Molding - Scratch & Dent - Large / (L) Front Fender, Molding - Scratch & Dent - Small / Front Bumper, Grille, Lamps - Crack, Gap - Large / Bonnet, Headlight - Scratch - Minimal / Roof - Scratch - Minimal</p>
