General Information

Make	Toyota	Model	Vios
YOM	2024	Odo Meter Reading	5,211
Registration No.	CCA6826	Chassis No.	PA1B18F34R4249286
CC	1.3	Transmission	CVT
Fuel Type	Gas	Type of Body	Sedan
Colour	Silver

Body / Panel Condition

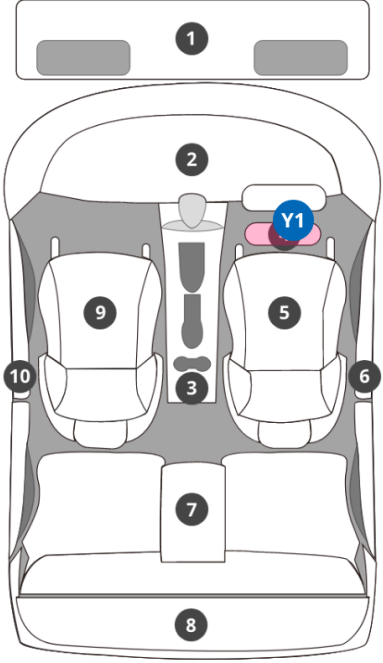
<p>a : Cut, Fray d : Loose, Deformed k : Animal Hair s : Smell t : Cigarette Burns x : Defective y : Stain</p>

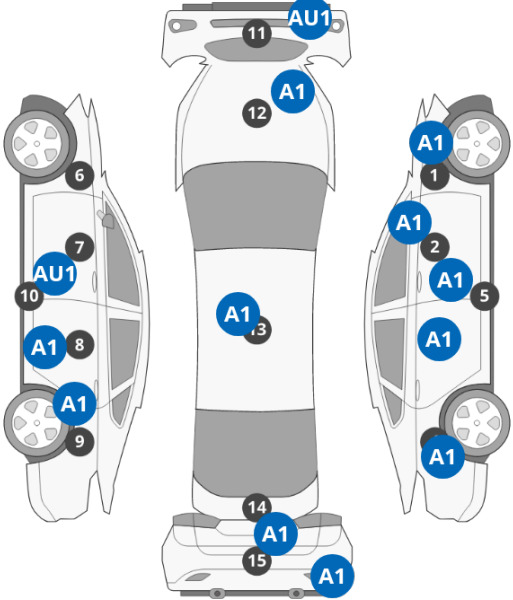
<p>A : Scratch AU : Scratch & Dent B : Modified C : Corrosion G : Stone chip P : Faded S : Rust SC : Rust & Corrosion U : Dent X : Defective Y : Crack, Gap</p>
Remarks (R) Front Floor Mat - Grime - Minimal	Remarks (R) Front Fender - Repair Traces - Yes / Bonnet - Repair Traces - Yes / (R) Front Fender, Molding - Scratch - Minimal / (R) Mirror - Scratch - Minimal / (R) Front Door, Molding - Scratch - Minimal / (R) Rear Door, Molding - Scratch - Minimal / (R) Rear Fender, Molding - Scratch - Minimal / Trunk Hood, Rear Gate - Scratch - Minimal / Rear Bumper, Lamps, Panels - Scratch - Minimal / (L) Rear Fender, Molding - Scratch - Minimal / (L) Rear Door, Molding - Scratch - Minimal / (L) Front Door, Molding - Scratch & Dent - Minimal / Front Bumper, Grille, Lamps - Scratch & Dent - Minimal / Bonnet, Headlight - Scratch - Minimal / Roof - Scratch - Minimal
