General Information

Make	Toyota	Model	Vios
YOM	2024	Odo Meter Reading	14,795
Registration No.	NHM6629	Chassis No.	PA1B18F33R4243138
CC	1.3	Transmission	CVT
Fuel Type	Gas	Type of Body	Sedan
Colour	Blackish Red Mica

Body / Panel Condition

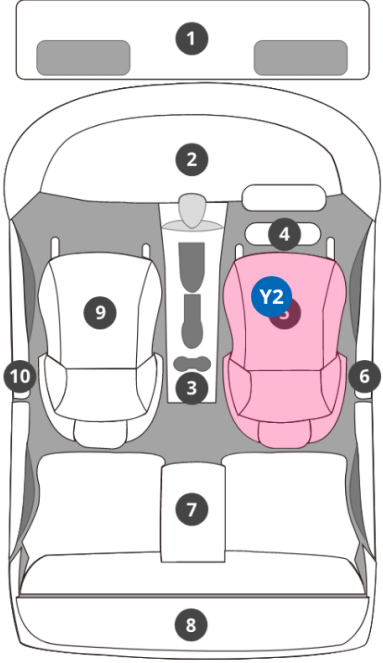
Interior Evaluation : A	Exterior Evaluation : C

<p>a : Cut, Fray d : Loose, Deformed k : Animal Hair s : Smell t : Cigarette Burns x : Defective y : Stain</p>

<p>A : Scratch AU : Scratch & Dent B : Modified C : Corrosion G : Stone chip P : Faded S : Rust SC : Rust & Corrosion U : Dent X : Defective Y : Crack, Gap</p>
Remarks (R) Front Seat - Grime - Small	Remarks (R) Front Fender, Molding - Scratch - Minimal / (R) Mirror - Scratch - Small / (R) Front Door, Molding - Scratch - Medium / (R) Step, In-panel, Side Spoiler - Scratch - Small / (R) Rear Door, Molding - Scratch - Minimal / Front Windshield - Scratch, Stone chip - Small / (R) Rear Fender, Molding - Scratch - Medium / Rear Bumper, Lamps, Panels - Scratch & Dent - Medium / Trunk Hood, Rear Gate - Scratch - Minimal / (L) Rear Fender, Molding - Scratch & Dent - Minimal / (L) Rear Door, Molding - Scratch - Minimal / (L) Front Door, Molding - Scratch - Minimal / (L) Front Fender, Molding - Scratch - Minimal / Roof - Scratch - Minimal / Bonnet, Headlight - Scratch - Minimal / Front Bumper, Grille, Lamps - Scratch - Medium

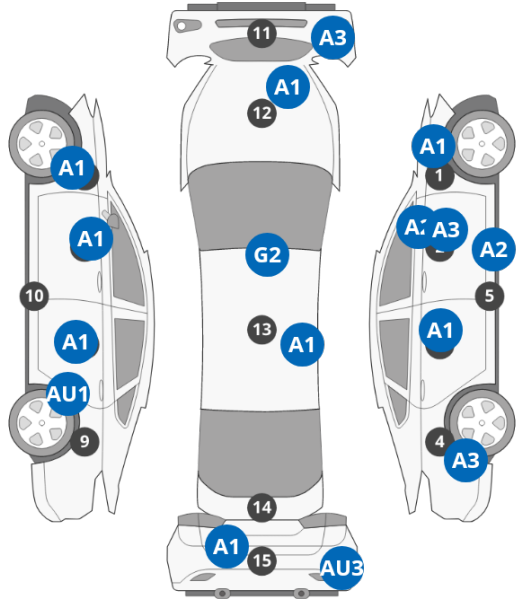
Inspector Notes
With Lto plate, with spare tire and jack, 2keys, no warranty booklet and tools, scratches on headlights and taillights
