General Information

Make	Toyota	Model	Vios
YOM	2022	Odo Meter Reading	43,366
Registration No.	NFK3504	Chassis No.	PA1B18F32N4175084
CC	1.3	Transmission	CVT
Fuel Type	Gas	Type of Body	Sedan
Colour	Silver

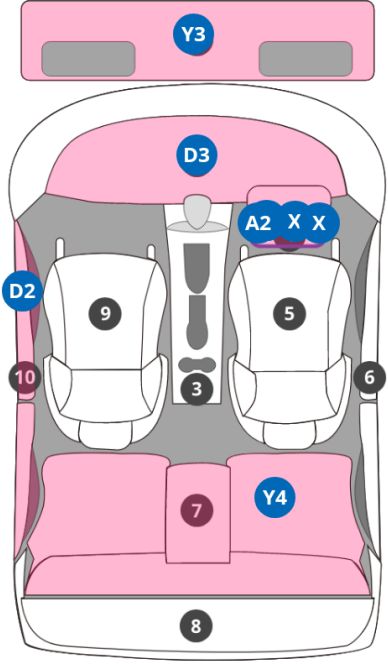
Interior Evaluation : C	Exterior Evaluation : E

<p>a : Cut, Fray d : Loose, Deformed k : Animal Hair s : Smell t : Cigarette Burns x : Defective y : Stain</p>

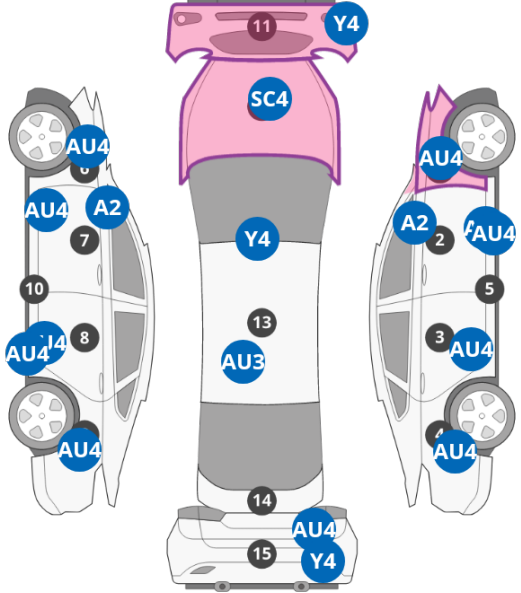
<p>A : Scratch AU : Scratch & Dent B : Modified C : Corrosion G : Stone chip P : Faded S : Rust SC : Rust & Corrosion U : Dent X : Defective Y : Crack, Gap</p>
<p>Remarks (R) Front Floor Mat - Missing - Yes / (L) Front Floor Mat - Missing - Yes / Mat Other - Missing - Yes / Carpet - Worn, Scratch, Cut, Crack - Small / Ceiling - Grime - Medium / Rear Seat - Grime - Large / (L) Front Trim - Loose, Deformed - Small / Glove Box - Loose, Deformed - Medium</p>	<p>Remarks (R) Front Door - Repair Traces - Yes / (R) Step - Repair Traces - Yes / (R) Front Fender - Repair Traces - Yes / Bonnet - Repair Traces - Yes / (L) Front Fender - Repair Traces - Yes / (L) Front Door - Repair Traces - Yes / (L) Rear Door - Repair Traces - Yes / (L) Rear Fender - Repair Traces - Yes / Trunk Hood, Rear Gate - Repair Traces - Yes / (R) Rear Door - Repair Traces - Yes / Roof - Repair Traces - Yes / Overall Exterior - Worn as per age - Yes / (R) Front Fender, Molding - Repair mark - Difference in Color / (R) Front Fender, Molding - Scratch & Dent - Large / Front Windshield - Damaged - Large / (R) Mirror - Scratch - Small / (R) Front Door, Molding - Scratch & Dent - Medium / (R) Step, In-panel, Side Spoiler - Scratch & Dent - Large / (R) Rear Door, Molding - Scratch & Dent - Large / (R) Rear Fender, Molding - Scratch & Dent - Large / Trunk Hood, Rear Gate - Scratch & Dent - Large / Rear Bumper, Lamps, Panels - Crack, Gap - Large / (L) Rear Fender, Molding - Scratch & Dent - Large / (L) Rear Door, Molding - Scratch & Dent - Large / (L) Step, In-panel, Side Spoiler - Scratch & Dent - Large / (L) Mirror - Scratch - Small / (L) Front Door, Molding - Scratch & Dent - Large / (L) Front Fender, Molding - Scratch & Dent - Large / Roof - Scratch & Dent - Medium / Front Bumper, Grille, Lamps - Repair mark - Yes / Bonnet, Headlight - Repair mark - Yes / Front Bumper, Grille, Lamps - Crack, Gap - Large / Bonnet, Headlight - Rust, Corrosion - Large</p>
