General Information

Make	Toyota	Model	Vios
YOM	2025	Odo Meter Reading	16,190
Registration No.	CCG8724	Chassis No.	PA1B18F39S4286775
CC	1.3	Transmission	CVT
Fuel Type	Gas	Type of Body	Sedan
Colour	Red

Body / Panel Condition

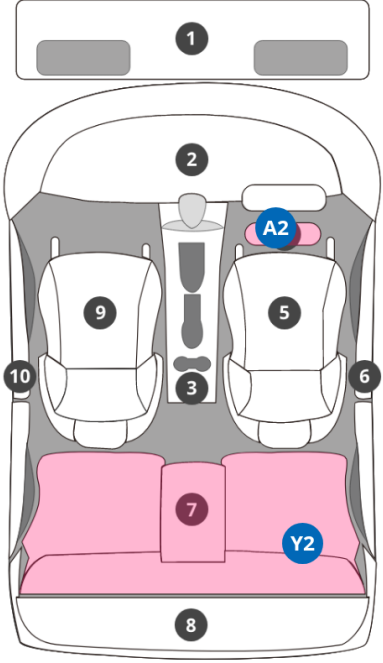
<p>a : Cut, Fray d : Loose, Deformed k : Animal Hair s : Smell t : Cigarette Burns x : Defective y : Stain</p>

<p>A : Scratch AU : Scratch & Dent B : Modified C : Corrosion G : Stone chip P : Faded S : Rust SC : Rust & Corrosion U : Dent X : Defective Y : Crack, Gap</p>
<p>Remarks (L) Front Floor Mat - Cut, Crack - Small / Rear Seat - Grime - Small</p>	<p>Remarks (R) Front Fender - Repair Traces - Yes / (R) Front Fender, Molding - Scratch - Minimal / (R) Mirror - Scratch - Minimal / (R) Front Door, Molding - Scratch - Minimal / (R) Rear Door, Molding - Scratch - Minimal / (R) Rear Fender, Molding - Scratch - Minimal / Rear Bumper, Lamps, Panels - Scratch & Dent - Small / Trunk Hood, Rear Gate - Scratch - Minimal / (L) Rear Fender, Molding - Scratch - Minimal / (L) Rear Door, Molding - Scratch - Minimal / (L) Mirror - Scratch - Minimal / (L) Front Door, Molding - Scratch - Minimal / (L) Front Fender, Molding - Scratch - Minimal / Front Bumper, Grille, Lamps - Scratch - Small / Bonnet, Headlight - Scratch - Minimal</p>
