## General Information

| <b>Make</b> | Toyota | <b>Model</b> | Vios |
| <b>Registration No.</b> | NHQ4494 | <b>Chassis No.</b> | PA1B18F37P4238604 |

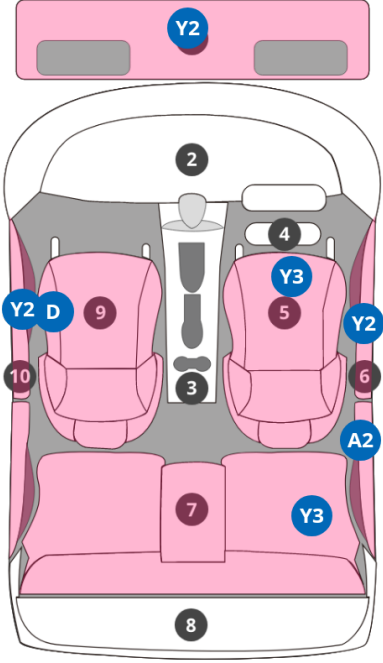
| <b>Interior Evaluation :</b> <span style="float: right; color: red; font-weight: bold;">C</span> | <b>Exterior Evaluation :</b> <span style="float: right; color: red; font-weight: bold;">E</span> |

| <p><b>Remarks</b><br/>Rear Seat - Grime - Medium / (R) Front Seat - Grime - Medium / (L) Front Seat - Worn - Yes / (R) Front Trim - Grime - Small / (L) Front Trim - Grime - Small / Ceiling - Grime - Small / (R) Rear Trim - Cut, Crack - Small</p> | <p><b>Remarks</b><br/>Member (Bolted) - Dent - Yes / (R) Mirror - Scratch - Small / (R) Front Fender, Molding - Scratch - Small / (R) Rear Door, Molding - Scratch - Small / (R) Front Door, Molding - Scratch - Medium / (R) Rear Fender, Molding - Scratch - Minimal / (R) Rear Fender, Molding - Repair mark - Yes / Rear Bumper, Lamps, Panels - Repair mark - Yes / Rear Bumper, Lamps, Panels - Scratch - Medium / Trunk Hood, Rear Gate - Scratch - Small / (L) Rear Fender, Molding - Repair mark - Yes / (L) Rear Fender, Molding - Scratch - Minimal / (L) Rear Door, Molding - Scratch - Small / (L) Front Door, Molding - Scratch - Small / (L) Mirror - Scratch - Small / Front Bumper, Grille, Lamps - Repair mark - Yes / (L) Front Fender, Molding - Scratch - Small / Front Bumper, Grille, Lamps - Scratch - Small / Bonnet, Headlight - Scratch - Small / Roof - Scratch &amp; Dent - Minimal</p> |

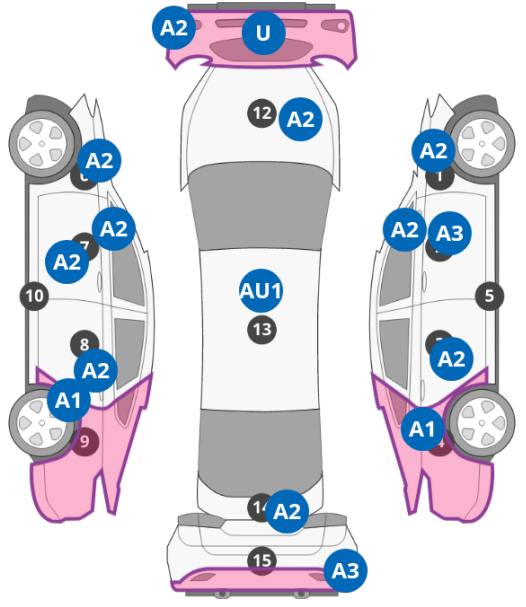
| <p>with warranty booklet, with jack, incomplete tools, with spare tire, with LTO plate, scratches on tail light</p> |
