## General Information

Date & Time: 20, Jan, 2026 08:31

<b>Make</b>	Toyota	<b>Model</b>	Vios
<b>YOM</b>	2025	<b>Odo Meter Reading</b>	24,314
<b>Registration No.</b>	NKE6457	<b>Chassis No.</b>	PA1B18F34R4262944
<b>CC</b>	1.3	<b>Transmission</b>	CVT
<b>Fuel Type</b>	Gas	<b>Type of Body</b>	Sedan
<b>Colour</b>	Red Mica Metallic

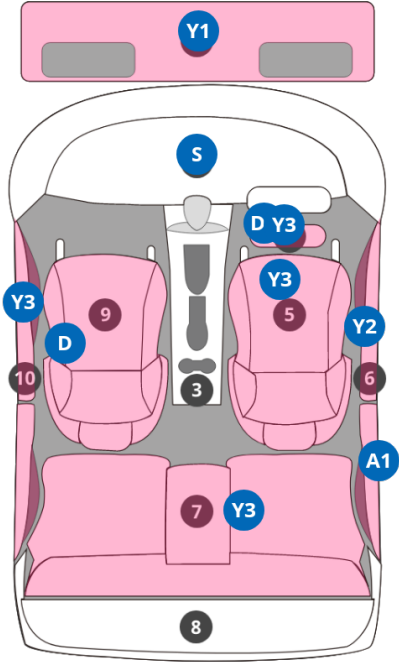
<b>Interior Evaluation :</b> <span style="color: red; font-weight: bold; font-size: 1.2em;">C</span>	<b>Exterior Evaluation :</b> <span style="color: red; font-weight: bold; font-size: 1.2em;">D</span>

<p><b>a</b> : Cut, Fray <b>d</b> : Loose, Deformed <b>k</b> : Animal Hair <b>s</b> : Smell <b>t</b> : Cigarette Burns <b>x</b> : Defective <b>y</b> : Stain</p>

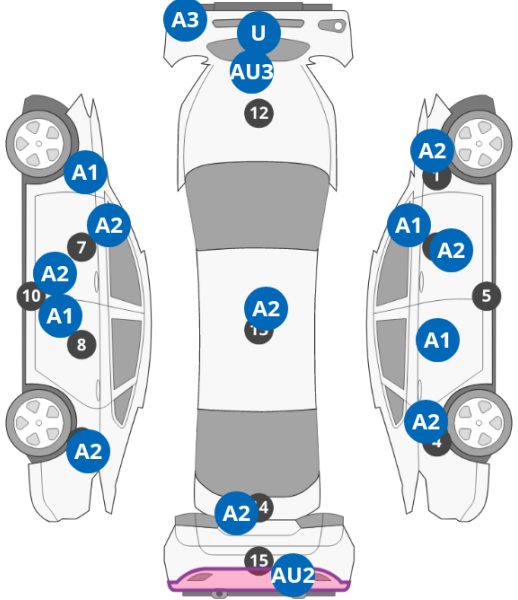
<p><b>A</b> : Scratch <b>AU</b> : Scratch &amp; Dent <b>B</b> : Modified <b>C</b> : Corrosion <b>G</b> : Stone chip <b>P</b> : Faded <b>S</b> : Rust <b>SC</b> : Rust &amp; Corrosion <b>U</b> : Dent <b>X</b> : Defective <b>Y</b> : Crack, Gap</p>
<p><b>Remarks</b> Rear Seat - Grime - Medium / (R) Front Seat - Grime - Medium / (L) Front Seat - Worn - Yes / (L) Front Floor Mat - Worked - Small / Mat Other - Grime - Medium / (R) Rear Trim - Cut, Crack - Minimal / (R) Front Trim - Grime - Small / (L) Front Trim - Grime - Medium / Ceiling - Grime - Minimal / Overall Interior - Smell - Yes</p>	<p><b>Remarks</b> Member (Bolted) - Dent - Yes / (R) Front Fender, Molding - Scratch - Small / (R) Mirror - Scratch - Minimal / (R) Front Door, Molding - Scratch - Small / (R) Rear Door, Molding - Scratch - Minimal / (R) Rear Fender, Molding - Scratch - Small / Rear Bumper, Lamps, Panels - Scratch &amp; Dent - Small / Rear Bumper, Lamps, Panels - Repair mark - Yes / Trunk Hood, Rear Gate - Scratch - Small / (L) Rear Fender, Molding - Scratch - Small / (L) Front Door, Molding - Scratch - Small / (L) Rear Door, Molding - Scratch - Minimal / (L) Mirror - Scratch - Small / (L) Front Fender, Molding - Scratch - Minimal / Front Bumper, Grille, Lamps - Scratch - Medium / Bonnet, Headlight - Scratch &amp; Dent - Medium / Roof - Scratch - Small</p>

<p><b>Inspector Notes</b></p>
<p>no warranty booklet, tools, with jack, with spare tire, with LTO plate, possible flooding, scratches on tail light,</p>
