General Information

Make	Toyota	Model	Vios
YOM	2024	Odo Meter Reading	30,817
Registration No.	NFR3842	Chassis No.	PA1B18F31R4252887
CC	1.3	Transmission	CVT
Fuel Type	Gas	Type of Body	Sedan
Colour	Silver

Body / Panel Condition

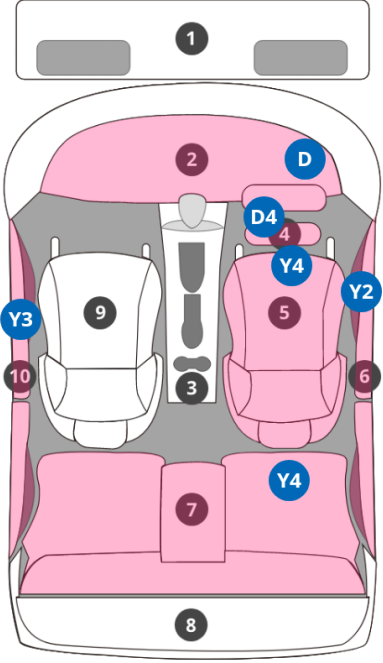
Interior Evaluation : C	Exterior Evaluation : D

<p>a : Cut, Fray d : Loose, Deformed k : Animal Hair s : Smell t : Cigarette Burns x : Defective y : Stain</p>

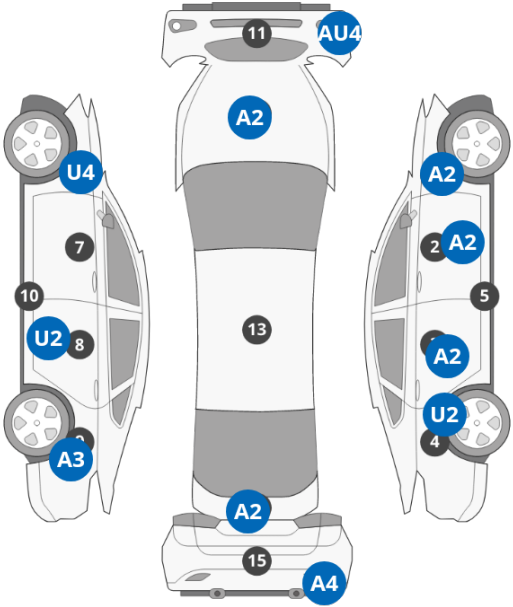
<p>A : Scratch AU : Scratch & Dent B : Modified C : Corrosion G : Stone chip P : Faded S : Rust SC : Rust & Corrosion U : Dent X : Defective Y : Crack, Gap</p>
<p>Remarks Rear Seat - Grime - Large / (R) Front Trim - Grime - Small / (R) Front Seat - Grime - Large / Dashboard - Traces of Adhesive Tape - Yes / (L) Front Trim - Grime - Medium / (L) Front Floor Mat - Worked - Large</p>	<p>Remarks Front Bumper, Grille, Lamps - Scratch & Dent - Large / (L) Front Fender, Molding - Dent - Large / (L) Rear Door, Molding - Dent - Small / (L) Rear Fender, Molding - Scratch - Medium / Rear Bumper, Lamps, Panels - Scratch - Large / (R) Rear Door, Molding - Scratch - Small / (R) Front Door, Molding - Scratch - Small / (R) Front Fender, Molding - Scratch - Small / Trunk Hood, Rear Gate - Scratch - Small / (R) Rear Fender, Molding - Dent - Small / Bonnet, Headlight - Scratch - Small</p>
