General Information

Make	Toyota	Model	Vios
YOM	2023	Odo Meter Reading	70,380
Registration No.	NHR1937	Chassis No.	PA1B18F33P4225798
CC	1.3	Transmission	CVT
Fuel Type	Gas	Type of Body	Sedan
Colour	Black

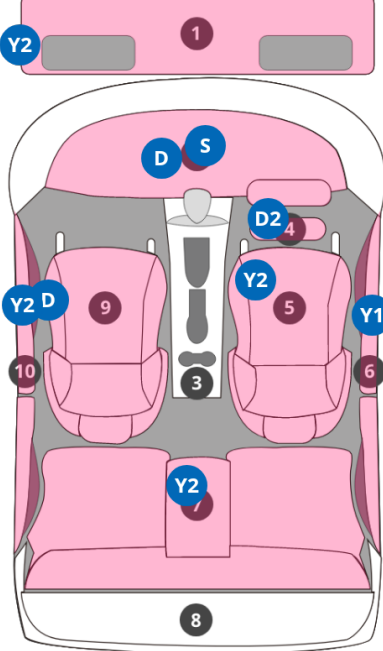
Interior Evaluation : B	Exterior Evaluation : E

<p>a : Cut, Fray d : Loose, Deformed k : Animal Hair s : Smell t : Cigarette Burns x : Defective y : Stain</p>

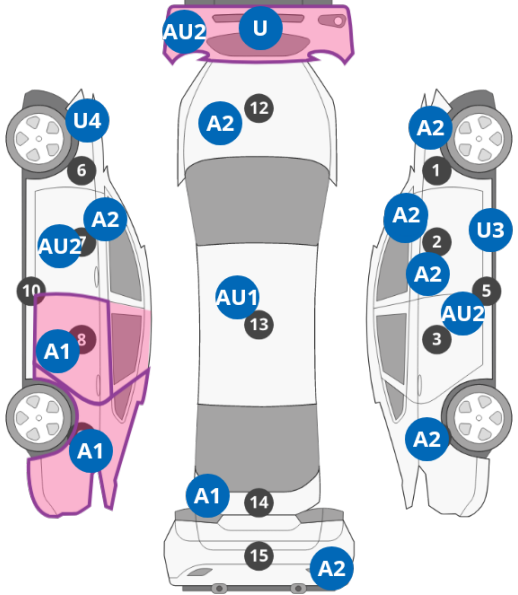
<p>A : Scratch AU : Scratch & Dent B : Modified C : Corrosion G : Stone chip P : Faded S : Rust SC : Rust & Corrosion U : Dent X : Defective Y : Crack, Gap</p>
<p>Remarks (L) Front Seat - Worn - Yes / (R) Front Seat - Grime - Small / Overall Interior - Smell - Yes / (L) Front Floor Mat - Worked - Small / (L) Front Trim - Grime - Small / (R) Front Trim - Grime - Minimal / Rear Seat - Grime - Small / Ceiling - Grime - Small / Dashboard - Traces of Adhesive Tape - Yes</p>	<p>Remarks (R) Front Fender - Repair Traces - Yes / Bonnet - Repair Traces - Yes / (L) Front Fender - Repair Traces - Yes / (R) Mirror - Faded(Color, Gloss) - Yes / (R) Mirror - Scratch - Small / (R) Front Fender, Molding - Scratch - Small / (R) Rear Door, Molding - Scratch & Dent - Small / (R) Front Door, Molding - Scratch - Small / (R) Step, In-panel, Side Spoiler - Dent - Medium / (R) Rear Fender, Molding - Scratch - Small / Rear Bumper, Lamps, Panels - Scratch - Small / Trunk Hood, Rear Gate - Scratch - Minimal / (L) Rear Fender, Molding - Scratch - Minimal / (L) Mirror - Scratch - Small / (L) Front Door, Molding - Scratch & Dent - Small / (L) Rear Fender, Molding - Repair mark - Yes / (L) Rear Door, Molding - Repair mark - Yes / (L) Rear Door, Molding - Scratch - Minimal / (L) Front Fender, Molding - Dent - Large / Member (Bolted) - Dent - Yes / Front Bumper, Grille, Lamps - Repair mark - Yes / Front Bumper, Grille, Lamps - Scratch & Dent - Small / Bonnet, Headlight - Scratch - Small / Roof - Scratch & Dent - Minimal</p>
