General Information

Make	Toyota	Model	Vios
YOM	2020	Odo Meter Reading	88,808
Registration No.	NEF5576	Chassis No.	PA1B18F30L4111607
CC	1.3	Transmission	M/T
Fuel Type	Gas	Type of Body	Sedan
Colour	Green

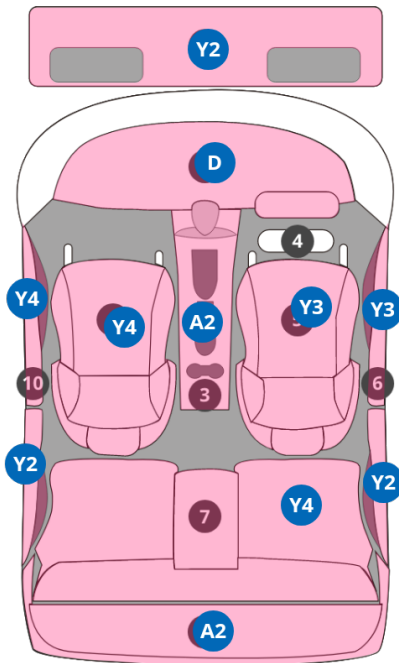
Interior Evaluation : E	Exterior Evaluation : E

<p>a : Cut, Fray d : Loose, Deformed k : Animal Hair s : Smell t : Cigarette Burns x : Defective y : Stain</p>

<p>A : Scratch AU : Scratch & Dent B : Modified C : Corrosion G : Stone chip P : Faded S : Rust SC : Rust & Corrosion U : Dent X : Defective Y : Crack, Gap</p>
Remarks (R) Front Seat - Grime - Medium / (R) Front Trim - Grime - Medium / (R) Rear Trim - Grime - Small / Rear Seat - Grime - Large / Trunk Room - Worn, Scratch, Cut, Crack - Small / (L) Rear Trim - Grime - Small / (L) Front Trim - Grime - Large / (L) Front Seat - Grime - Large / Console, Switches, Vents - Worn, Scratch, Cut, Crack - Small / Dashboard - Traces of Adhesive Tape - Yes / Ceiling - Grime - Small	Remarks (R) Rear Fender - Repair Traces - Yes / (R) Rear Door - Repair Traces - Yes / Bonnet, Headlight - Scratch & Dent - Medium / Front Bumper, Grille, Lamps - Scratch - Large / (L) Mirror - Scratch - Small / (L) Front Fender, Molding - Scratch & Dent - Medium / (L) Front Door, Molding - Scratch - Medium / (L) Rear Door, Molding - Scratch & Dent - Small / (L) Step, In-panel, Side Spoiler - Scratch & Dent - Large / (L) Rear Fender, Molding - Scratch - Small / Rear Bumper, Lamps, Panels - Scratch - Large / Trunk Hood, Rear Gate - Scratch & Dent - Medium / (R) Rear Fender, Molding - Scratch - Medium / (R) Rear Door, Molding - Scratch - Medium / (R) Front Door, Molding - Scratch - Medium / (R) Mirror - Scratch - Small / (R) Front Fender, Molding - Scratch & Dent - Large / (R) Step, In-panel, Side Spoiler - Scratch & Dent - Large / Roof - Scratch & Dent - Small
