General Information

Make	Toyota	Model	Vios
YOM	2024	Odo Meter Reading	40,108
Registration No.	DBO4299	Chassis No.	PA1B18F36P4236813
CC	1.3	Transmission	CVT
Fuel Type	Gas	Type of Body	Sedan
Colour	Red Mica Metallic

Body / Panel Condition

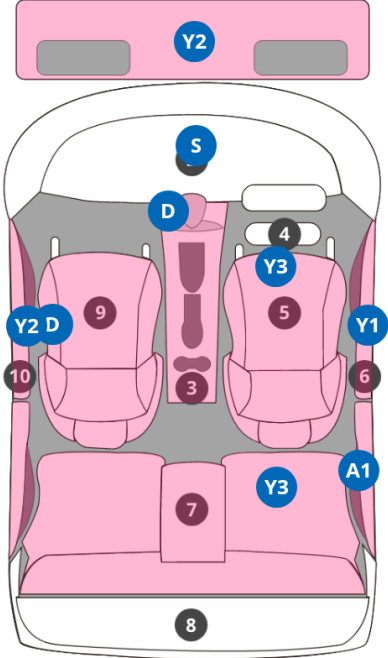
<p>a : Cut, Fray d : Loose, Deformed k : Animal Hair s : Smell t : Cigarette Burns x : Defective y : Stain</p>

<p>A : Scratch AU : Scratch & Dent B : Modified C : Corrosion G : Stone chip P : Faded S : Rust SC : Rust & Corrosion U : Dent X : Defective Y : Crack, Gap</p>
<p>Remarks (L) Front Seat - Worn - Yes / (R) Front Seat - Grime - Medium / (R) Rear Trim - Cut, Crack - Minimal / (R) Front Trim - Grime - Minimal / (L) Front Trim - Grime - Small / Rear Seat - Grime - Medium / Ceiling - Grime - Small / Console, Switches, Vents - Traces of Adhesive Tape - Yes / Overall Interior - Smell - Yes</p>	<p>Remarks (R) Mirror - Scratch - Small / (R) Front Fender, Molding - Scratch - Small / (R) Step, In-panel, Side Spoiler - Scratch - Small / (R) Front Door, Molding - Scratch - Small / (R) Rear Door, Molding - Scratch - Small / (R) Rear Fender, Molding - Scratch - Minimal / Rear Bumper, Lamps, Panels - Scratch - Medium / Trunk Hood, Rear Gate - Scratch & Dent - Minimal / (L) Rear Fender, Molding - Dent - Small / (L) Rear Door, Molding - Scratch & Dent - Small / (L) Mirror - Scratch - Small / (L) Front Door, Molding - Scratch - Minimal / (L) Front Fender, Molding - Scratch - Minimal / Member (Bolted) - Dent - Yes / Front Bumper, Grille, Lamps - Scratch & Dent - Medium / Bonnet, Headlight - Scratch & Dent - Minimal / Roof - Scratch - Small</p>

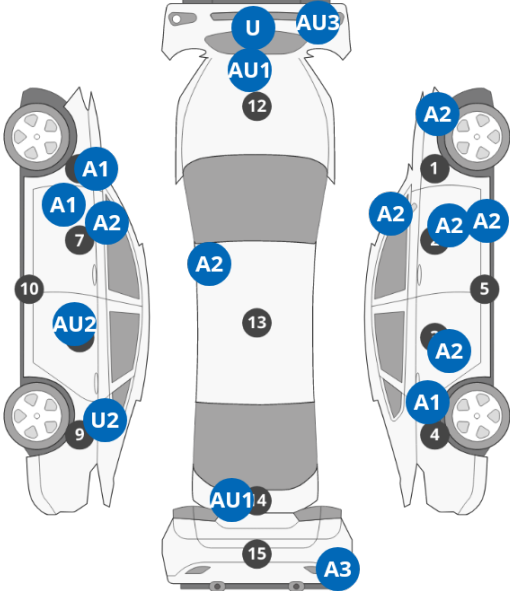
<p>Inspector Notes</p>
<p>with warranty booklet, jack and tools, with spare tire, with LTO plate, possible flooding, scratches on tail light, right side mirror issue</p>
