General Information

Make	Toyota	Model	Vios
YOM	2025	Odo Meter Reading	18,973
Registration No.	DBP3854	Chassis No.	PA1B18F37R4262260
CC	1.3	Transmission	CVT
Fuel Type	Gas	Type of Body	Sedan
Colour	Blue

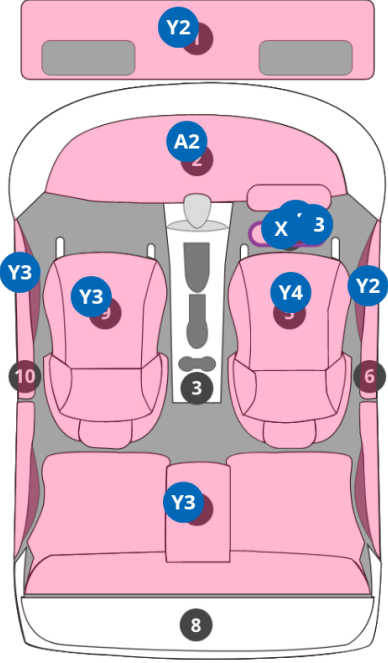
Interior Evaluation : C	Exterior Evaluation : C

<p>a : Cut, Fray d : Loose, Deformed k : Animal Hair s : Smell t : Cigarette Burns x : Defective y : Stain</p>

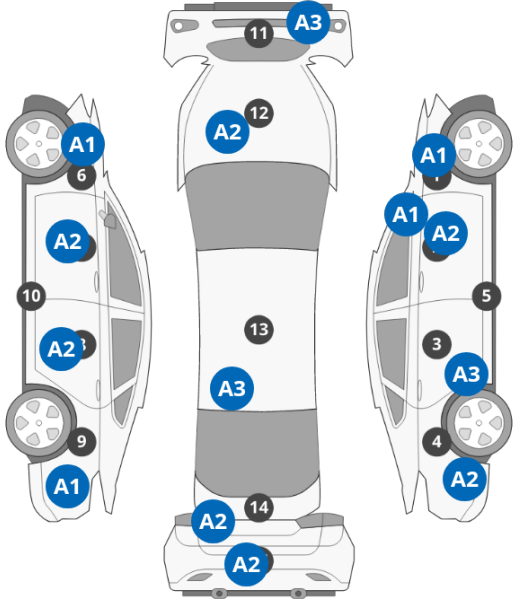
<p>A : Scratch AU : Scratch & Dent B : Modified C : Corrosion G : Stone chip P : Faded S : Rust SC : Rust & Corrosion U : Dent X : Defective Y : Crack, Gap</p>
<p>Remarks (R) Front Seat - Grime - Large / (R) Front Trim - Grime - Small / Rear Seat - Grime - Medium / (L) Front Trim - Grime - Medium / (L) Front Floor Mat - Grime - Medium / (L) Front Seat - Grime - Medium / Ceiling - Grime - Small / Dashboard - Worn, Scratch, Cut, Crack - Small / (R) Front Floor Mat - Missing - Yes / Mat Other - Missing - Yes</p>	<p>Remarks Trunk Hood, Rear Gate - Scratch - Small / Rear Bumper, Lamps, Panels - Scratch - Small / (R) Rear Fender, Molding - Scratch - Small / (R) Rear Door, Molding - Scratch - Medium / (R) Front Door, Molding - Scratch - Small / (R) Front Fender, Molding - Scratch - Minimal / (R) Mirror - Scratch - Minimal / Front Bumper, Grille, Lamps - Scratch - Medium / Bonnet, Headlight - Scratch - Small / (L) Front Fender, Molding - Scratch - Minimal / (L) Front Door, Molding - Scratch - Small / (L) Rear Fender, Molding - Scratch - Minimal / (L) Rear Door, Molding - Scratch - Small / Roof - Scratch - Medium</p>
