## General Information

<b>Make</b>	Toyota	<b>Model</b>	Vios
<b>YOM</b>	2025	<b>Odo Meter Reading</b>	22,859
<b>Registration No.</b>	DBQ5590	<b>Chassis No.</b>	PA1B18F35R4272687
<b>CC</b>	1.3	<b>Transmission</b>	CVT
<b>Fuel Type</b>	Gas	<b>Type of Body</b>	Sedan
<b>Colour</b>	Black

## Body / Panel Condition

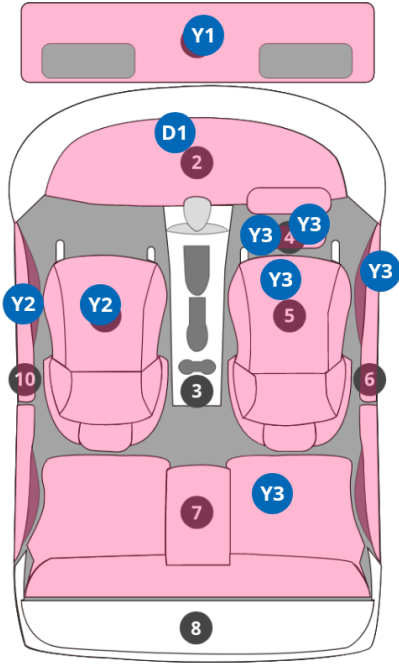
<b>Interior Evaluation :</b> <span style="color: red; font-weight: bold; font-size: 1.2em;">C</span>	<b>Exterior Evaluation :</b> <span style="color: red; font-weight: bold; font-size: 1.2em;">C</span>

<p><b>a</b> : Cut, Fray <b>d</b> : Loose, Deformed <b>k</b> : Animal Hair <b>s</b> : Smell <b>t</b> : Cigarette Burns <b>x</b> : Defective <b>y</b> : Stain</p>

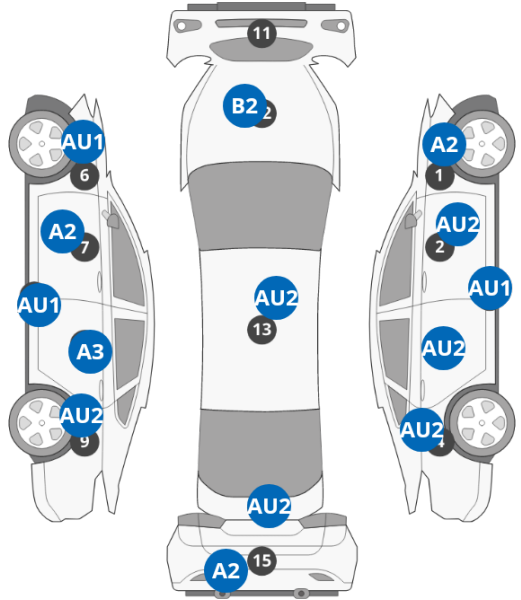
<p><b>A</b> : Scratch <b>AU</b> : Scratch &amp; Dent <b>B</b> : Modified <b>C</b> : Corrosion <b>G</b> : Stone chip <b>P</b> : Faded <b>S</b> : Rust <b>SC</b> : Rust &amp; Corrosion <b>U</b> : Dent <b>X</b> : Defective <b>Y</b> : Crack, Gap</p>
<p><b>Remarks</b> (L) Front Floor Mat - Grime - Medium / (R) Front Floor Mat - Grime - Medium / (R) Front Seat - Grime - Medium / Rear Seat - Grime - Medium / (L) Front Trim - Grime - Small / (R) Front Trim - Grime - Medium / (L) Front Seat - Grime - Small / Dashboard - Worked - Minimal / Ceiling - Grime - Minimal</p>	<p><b>Remarks</b> (L) Rear Door, Molding - Scratch - Medium / (L) Front Door, Molding - Scratch - Small / (L) Front Fender, Molding - Scratch &amp; Dent - Minimal / (L) Rear Fender, Molding - Scratch &amp; Dent - Small / Trunk Hood, Rear Gate - Scratch &amp; Dent - Small / (R) Rear Fender, Molding - Scratch &amp; Dent - Small / (R) Rear Door, Molding - Scratch &amp; Dent - Small / (R) Front Door, Molding - Scratch &amp; Dent - Small / (R) Front Fender, Molding - Scratch - Small / (R) Step, In-panel, Side Spoiler - Scratch &amp; Dent - Minimal / (L) Step, In-panel, Side Spoiler - Scratch &amp; Dent - Minimal / Roof - Scratch &amp; Dent - Small / Bonnet, Headlight - Modified - Small / Rear Bumper, Lamps, Panels - Scratch - Small</p>

<p><b>Inspector Notes</b></p>
<p>with LTO plate, with spare tire, with jack, with reverse camera, with manual and warranty booklet, scratches on taillight and headlight.</p>
