General Information

Make	Toyota	Model	Vios
YOM	2025	Odo Meter Reading	30,720
Registration No.	DBQ7296	Chassis No.	PA1B18F37R4270794
CC	1.3	Transmission	CVT
Fuel Type	Gas	Type of Body	Sedan
Colour	Silver

Body / Panel Condition

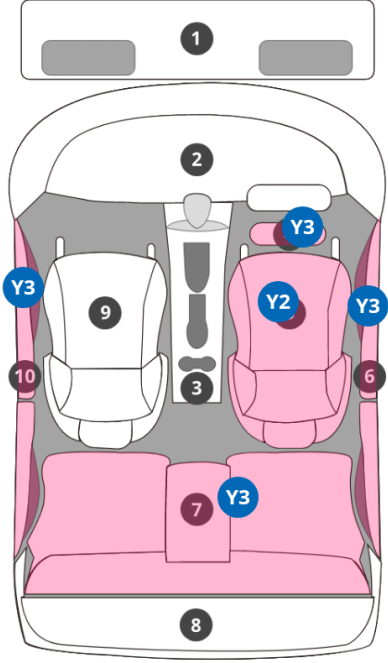
<p>a : Cut, Fray d : Loose, Deformed k : Animal Hair s : Smell t : Cigarette Burns x : Defective y : Stain</p>

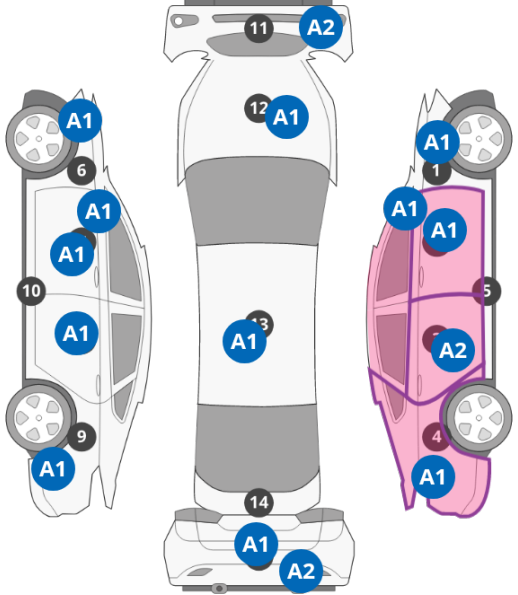
<p>A : Scratch AU : Scratch & Dent B : Modified C : Corrosion G : Stone chip P : Faded S : Rust SC : Rust & Corrosion U : Dent X : Defective Y : Crack, Gap</p>
<p>Remarks (R) Front Seat - Grime - Small / (R) Front Trim - Grime - Medium / Rear Seat - Grime - Medium / (L) Front Trim - Grime - Medium / (L) Front Floor Mat - Grime - Medium</p>	<p>Remarks (R) Front Door - Repair Traces - Yes / (R) Rear Fender - Repair Traces - Yes / (R) Rear Door - Repair Traces - Yes / (R) Front Door, Molding - Repair mark - Yes / (R) Rear Door, Molding - Repair mark - Yes / (R) Rear Fender, Molding - Repair mark - Yes / (L) Mirror - Scratch - Minimal / Front Bumper, Grille, Lamps - Scratch - Small / (R) Mirror - Scratch - Minimal / (R) Rear Door, Molding - Scratch - Small / Bonnet, Headlight - Scratch - Minimal / (R) Front Door, Molding - Scratch - Minimal / (R) Front Fender, Molding - Scratch - Minimal / (R) Rear Fender, Molding - Scratch - Minimal / Trunk Hood, Rear Gate - Scratch - Minimal / Rear Bumper, Lamps, Panels - Scratch - Small / (L) Rear Door, Molding - Scratch - Minimal / (L) Rear Fender, Molding - Scratch - Minimal / (L) Front Door, Molding - Scratch - Minimal / (L) Front Fender, Molding - Scratch - Minimal / Roof - Scratch - Minimal</p>
