General Information

Make	Toyota	Model	Vios
YOM	2025	Odo Meter Reading	44,367
Registration No.	DBQ2652	Chassis No.	PA1B18F38R4269055
CC	1.3	Transmission	CVT
Fuel Type	Gas	Type of Body	Sedan
Colour	Blue

Body / Panel Condition

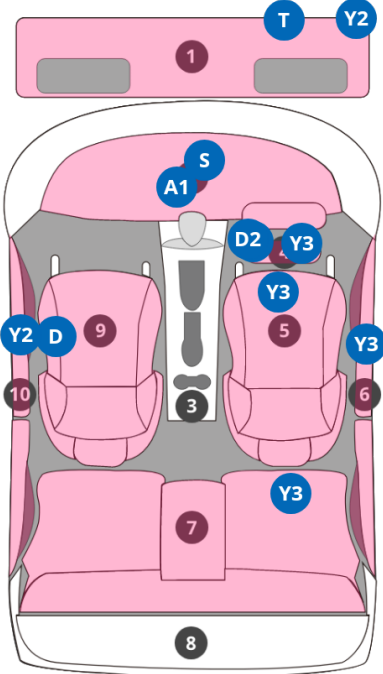
Interior Evaluation : D	Exterior Evaluation : C

<p>a : Cut, Fray d : Loose, Deformed k : Animal Hair s : Smell t : Cigarette Burns x : Defective y : Stain</p>

<p>A : Scratch AU : Scratch & Dent B : Modified C : Corrosion G : Stone chip P : Faded S : Rust SC : Rust & Corrosion U : Dent X : Defective Y : Crack, Gap</p>
<p>Remarks (L) Front Seat - Worn - Yes / (R) Front Seat - Grime - Medium / Rear Seat - Grime - Medium / Overall Interior - Smell - Yes / (R) Front Trim - Grime - Medium / (L) Front Trim - Grime - Small / (L) Front Floor Mat - Cut, Crack - Minimal / (L) Front Floor Mat - Worked - Small / (R) Front Floor Mat - Grime - Medium / Ceiling - Cigarette Burns - Burnt, Hole / Ceiling - Grime - Small / Dashboard - Worn, Scratch, Cut, Crack - Minimal</p>	<p>Remarks Member (Bolted) - Dent - Yes / (R) Mirror - Scratch - Minimal / (R) Front Fender, Molding - Scratch - Minimal / (R) Step, In-panel, Side Spoiler - Scratch - Minimal / (R) Front Door, Molding - Scratch - Minimal / (R) Rear Door, Molding - Scratch - Minimal / (R) Rear Fender, Molding - Scratch - Small / Rear Bumper, Lamps, Panels - Scratch & Dent - Medium / Trunk Hood, Rear Gate - Crack, Gap - Large / (L) Mirror - Scratch - Small / (L) Front Door, Molding - Scratch - Small / (L) Rear Door, Molding - Scratch - Minimal / (L) Front Fender, Molding - Scratch - Minimal / Front Bumper, Grille, Lamps - Scratch - Large / Bonnet, Headlight - Scratch - Minimal / Roof - Scratch - Minimal / (L) Rear Fender, Molding - Scratch - Small</p>

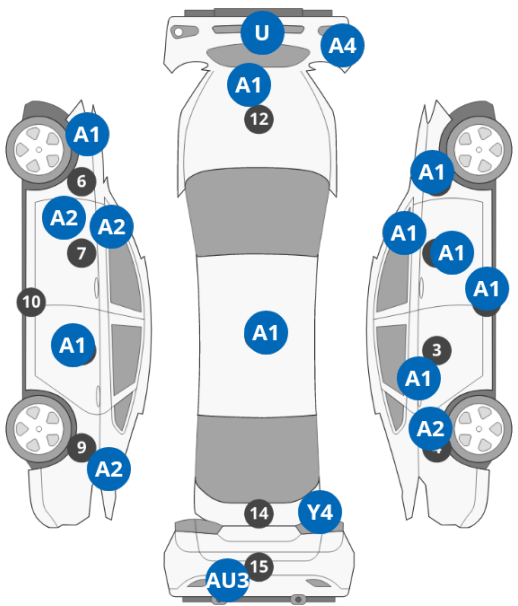
<p>Inspector Notes</p>
<p>with warranty booklet, jack, and tools, with spare tire, with LTO plate, possible flooding, scratches on tail light</p>
