General Information

Make	Toyota	Model	Avanza
YOM	2025	Odo Meter Reading	18,758
Registration No.	DBQ7900	Chassis No.	MHFAA1BY7R0032181
CC	1.3	Transmission	CVT
Fuel Type	Gas	Type of Body	MPV
Colour	Silver

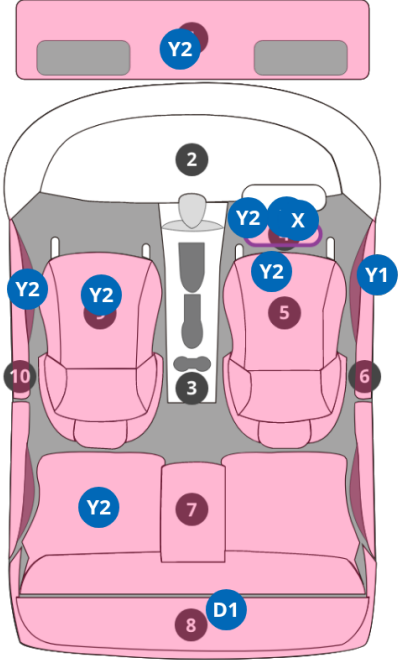
Interior Evaluation : B	Exterior Evaluation : E

<p>a : Cut, Fray d : Loose, Deformed k : Animal Hair s : Smell t : Cigarette Burns x : Defective y : Stain</p>

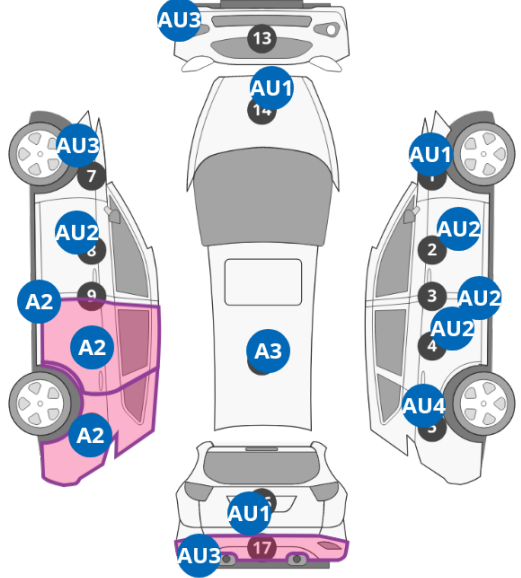
<p>A : Scratch AU : Scratch & Dent B : Modified C : Corrosion G : Stone chip P : Faded S : Rust SC : Rust & Corrosion U : Dent X : Defective Y : Crack, Gap</p>
Remarks (R) Front Floor Mat - Missing - Yes / Mat Other - Missing - Yes / (L) Front Floor Mat - Grime - Small / (R) Front Trim - Grime - Minimal / (L) Front Trim - Grime - Small / Rear Seat - Grime - Small / (L) Front Seat - Grime - Small / (R) Front Seat - Grime - Small / Ceiling - Grime - Small / Trunk Room - Worked - Minimal	Remarks (L) Step - Repair Traces - Yes / (L) Rear Door - Repair Traces - Yes / (L) Rear Fender - Repair Traces - Yes / (L) Front Fender, Molding - Scratch & Dent - Medium / Front Bumper, Grille, Lamps - Scratch & Dent - Medium / (L) Front Door, Molding - Scratch & Dent - Small / (L) Rear Door, Molding - Repair mark - Yes / (L) Rear Fender, Molding - Repair mark - Yes / (L) Rear Door, Molding - Scratch - Small / (L) Step, In-panel, Side Spoiler - Scratch - Small / (L) Rear Fender, Molding - Scratch - Small / Rear Bumper, Lamps, Panels - Repair mark - Yes / Rear Bumper, Lamps, Panels - Scratch & Dent - Medium / Trunk Hood, Rear Gate - Scratch & Dent - Minimal / (R) Rear Fender, Molding - Scratch & Dent - Large / (R) Step, In-panel, Side Spoiler - Scratch & Dent - Small / (R) Rear Door, Molding - Scratch & Dent - Small / (R) Front Door, Molding - Scratch & Dent - Small / Roof - Scratch - Medium / (R) Front Fender, Molding - Scratch & Dent - Minimal / Bonnet, Headlight - Scratch & Dent - Minimal
