General Information

Make	Toyota	Model	Wigo
YOM	2025	Odo Meter Reading	24,104
Registration No.	DBT2147	Chassis No.	MHKAA1BC1RJ034136
CC	1.0	Transmission	CVT
Fuel Type	Gas	Type of Body	Hatchback
Colour	Red

Body / Panel Condition

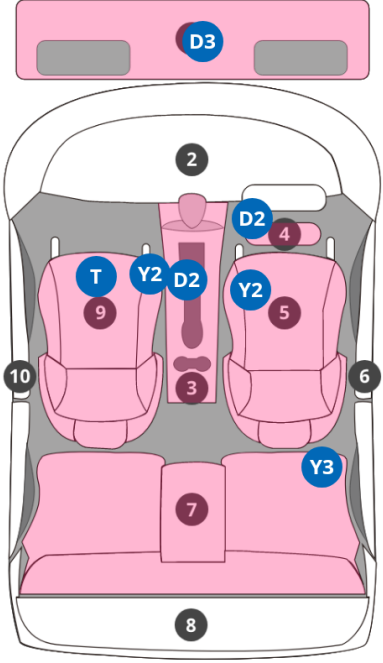
Interior Evaluation : C	Exterior Evaluation : E

<p>a : Cut, Fray d : Loose, Deformed k : Animal Hair s : Smell t : Cigarette Burns x : Defective y : Stain</p>

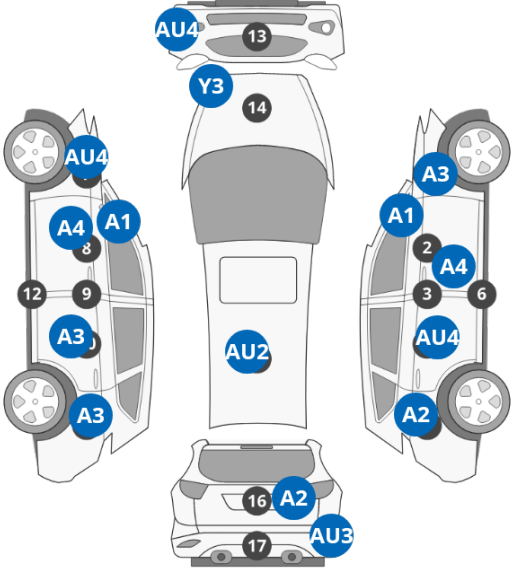
<p>A : Scratch AU : Scratch & Dent B : Modified C : Corrosion G : Stone chip P : Faded S : Rust SC : Rust & Corrosion U : Dent X : Defective Y : Crack, Gap</p>
<p>Remarks (L) Front Seat - Cigarette Burns - Burnt, Hole / (L) Front Seat - Grime - Small / (R) Front Seat - Grime - Small / (L) Front Floor Mat - Worked - Small / Ceiling - Crinkle - Medium / Rear Seat - Grime - Medium / Console, Switches, Vents - Loose, Deformed - Small</p>	<p>Remarks (R) Mirror - Scratch - Minimal / (R) Front Fender, Molding - Scratch - Medium / (R) Front Door, Molding - Scratch - Large / (R) Rear Door, Molding - Scratch & Dent - Large / (R) Rear Fender, Molding - Scratch - Small / Rear Bumper, Lamps, Panels - Scratch & Dent - Medium / Trunk Hood, Rear Gate - Scratch - Small / (L) Rear Fender, Molding - Scratch - Medium / (L) Rear Door, Molding - Scratch - Medium / (L) Front Door, Molding - Scratch - Large / (L) Front Fender, Molding - Scratch & Dent - Large / (L) Mirror - Scratch - Minimal / Front Bumper, Grille, Lamps - Scratch & Dent - Large / Bonnet, Headlight - Crack, Gap - Medium / Roof - Scratch & Dent - Small</p>
