General Information

Make	Toyota	Model	Vios
YOM	2018	Odo Meter Reading	46,476
Registration No.	NBS9181	Chassis No.	PA1B23F33J6005122
CC	1.5	Transmission	A/T
Fuel Type	Gas	Type of Body	Sedan
Colour	Green

Body / Panel Condition

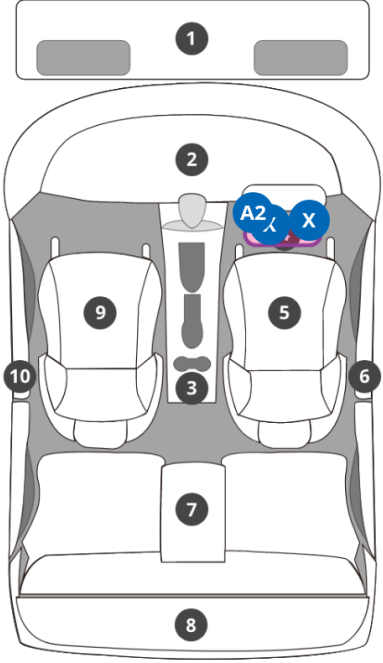
Interior Evaluation : B	Exterior Evaluation : C

<p>a : Cut, Fray d : Loose, Deformed k : Animal Hair s : Smell t : Cigarette Burns x : Defective y : Stain</p>

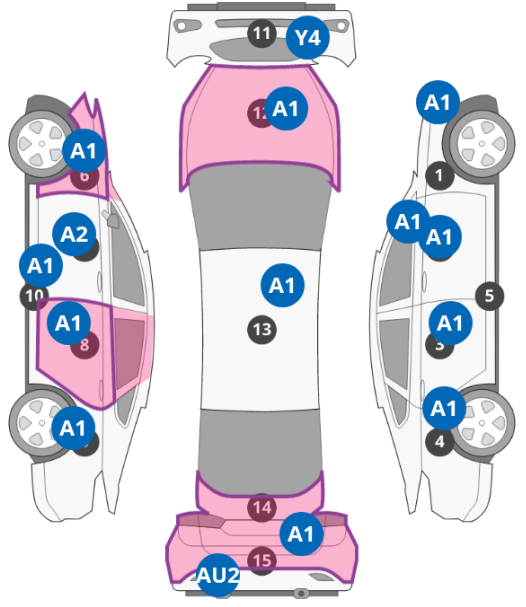
<p>A : Scratch AU : Scratch & Dent B : Modified C : Corrosion G : Stone chip P : Faded S : Rust SC : Rust & Corrosion U : Dent X : Defective Y : Crack, Gap</p>
Remarks (R) Front Floor Mat - Missing - Yes / (L) Front Floor Mat - Missing - Yes / Carpet - Worn, Scratch, Cut, Crack - Small	Remarks Bonnet - Repair Traces - Yes / (L) Front Fender - Repair Traces - Yes / (R) Front Fender, Molding - Scratch - Minimal / (R) Mirror - Scratch - Minimal / (R) Front Door, Molding - Scratch - Minimal / (R) Rear Door, Molding - Scratch - Minimal / (R) Rear Fender, Molding - Scratch - Minimal / Rear Bumper, Lamps, Panels - Scratch & Dent - Small / Trunk Hood, Rear Gate - Repair mark - Yes / (L) Rear Door, Molding - Repair mark - Difference in Color / Trunk Hood, Rear Gate - Scratch - Minimal / (L) Rear Fender, Molding - Scratch - Minimal / (L) Rear Door, Molding - Scratch - Minimal / (L) Front Door, Molding - Scratch - Small / (L) Step, In-panel, Side Spoiler - Scratch - Minimal / (L) Front Fender, Molding - Repair mark - Yes / (L) Front Fender, Molding - Scratch - Minimal / Bonnet, Headlight - Repair mark - Yes / Bonnet, Headlight - Scratch - Minimal / Roof - Scratch - Minimal / Front Bumper, Grille, Lamps - Crack, Gap - Large
