General Information

Make	Honda	Model	City
YOM	2019	Odo Meter Reading	44,193
Registration No.	NBS2242	Chassis No.	PADGM6620KV517295
CC	1.5	Transmission	A/T
Fuel Type	Gas	Type of Body	Sedan
Colour	Gray

Body / Panel Condition

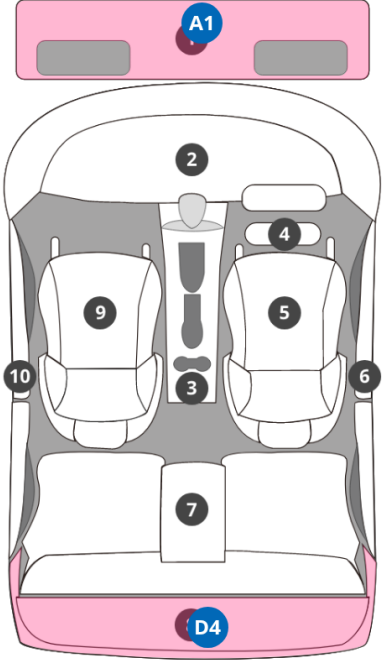
Interior Evaluation : C	Exterior Evaluation : D

<p>a : Cut, Fray d : Loose, Deformed k : Animal Hair s : Smell t : Cigarette Burns x : Defective y : Stain</p>

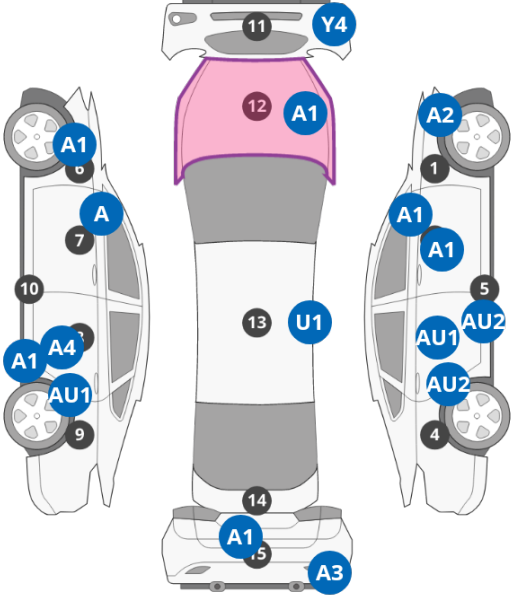
<p>A : Scratch AU : Scratch & Dent B : Modified C : Corrosion G : Stone chip P : Faded S : Rust SC : Rust & Corrosion U : Dent X : Defective Y : Crack, Gap</p>
<p>Remarks Ceiling - Cut, Crack - Minimal / Trunk Room - Loose, Deformed - Large</p>	<p>Remarks (L) Rear Door - Repair Traces - Yes / (R) Front Fender, Molding - Scratch - Small / (R) Mirror - Scratch, Peeled - Minimal / (R) Front Door, Molding - Scratch - Minimal / (R) Rear Door, Molding - Scratch & Dent - Minimal / (R) Step, In-panel, Side Spoiler - Scratch & Dent - Small / (R) Rear Fender, Molding - Scratch & Dent - Small / Rear Bumper, Lamps, Panels - Scratch - Medium / Trunk Hood, Rear Gate - Scratch - Minimal / (L) Rear Fender, Molding - Scratch & Dent - Minimal / (L) Rear Door, Molding - Scratch - Large / (L) Step, In-panel, Side Spoiler - Scratch - Minimal / (L) Mirror - Scratch, Peeled - Yes / (L) Front Fender, Molding - Scratch - Minimal / Bonnet, Headlight - Repair mark - Yes / Front Bumper, Grille, Lamps - Crack, Gap - Large / Roof - Dent - Minimal / Bonnet, Headlight - Scratch - Minimal</p>
