General Information

Make	Mitsubishi	Model	Xpander
YOM	2024	Odo Meter Reading	28,912
Registration No.	DBN9325	Chassis No.	MK2LRNC1WRN00226
CC	1.5	Transmission	A/T
Fuel Type	Gas	Type of Body	Wagon
Colour	Red

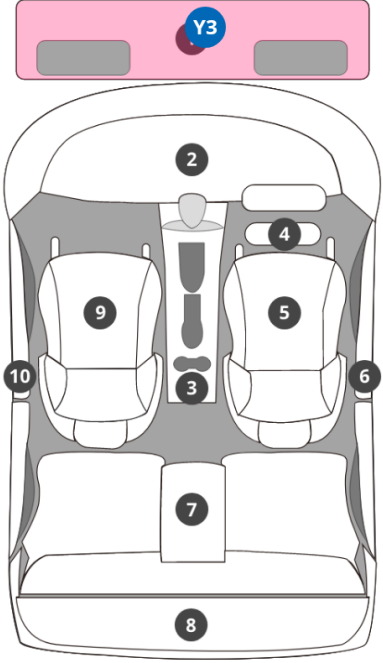
Interior Evaluation : B	Exterior Evaluation : C

<p>a : Cut, Fray d : Loose, Deformed k : Animal Hair s : Smell t : Cigarette Burns x : Defective y : Stain</p>

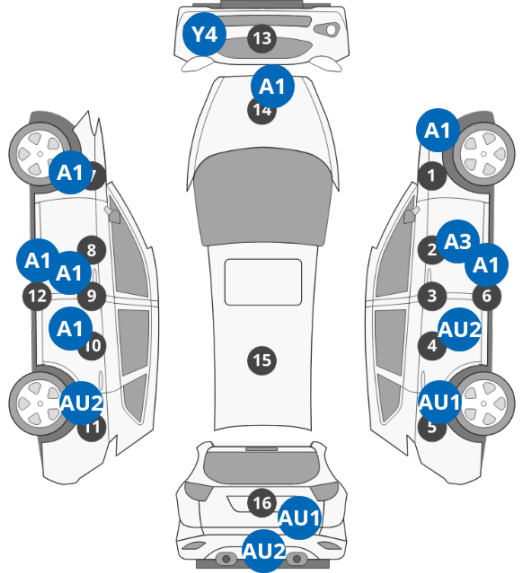
<p>A : Scratch AU : Scratch & Dent B : Modified C : Corrosion G : Stone chip P : Faded S : Rust SC : Rust & Corrosion U : Dent X : Defective Y : Crack, Gap</p>
Remarks Ceiling - Grime - Medium	Remarks Trunk Hood, Rear Gate - Repair Traces - Yes / (R) Front Fender, Molding - Scratch - Minimal / (R) Front Door, Molding - Scratch - Medium / (R) Rear Door, Molding - Scratch & Dent - Small / (R) Step, In-panel, Side Spoiler - Scratch - Minimal / (R) Rear Fender, Molding - Scratch & Dent - Minimal / Trunk Hood, Rear Gate - Scratch & Dent - Minimal / Rear Bumper, Lamps, Panels - Scratch & Dent - Small / (L) Rear Fender, Molding - Scratch & Dent - Small / (L) Rear Door, Molding - Scratch - Minimal / (L) Front Door, Molding - Scratch - Minimal / (L) Step, In-panel, Side Spoiler - Scratch - Minimal / (L) Front Fender, Molding - Scratch - Minimal / Front Bumper, Grille, Lamps - Crack, Gap - Large / Bonnet, Headlight - Scratch - Minimal

Inspector Notes
With Lto plate, with warranty booklet, with spare tire, 1key, no jack and tools, scratches on headlights and taillights, warning lamp on
