General Information

Make	Toyota	Model	Avanza
YOM	2016	Odo Meter Reading	87,363
Registration No.	NDS2278	Chassis No.	MHKM5FF3FGK000911
CC	1.5	Transmission	A/T
Fuel Type	Gas	Type of Body	Wagon
Colour	Gray

Body / Panel Condition

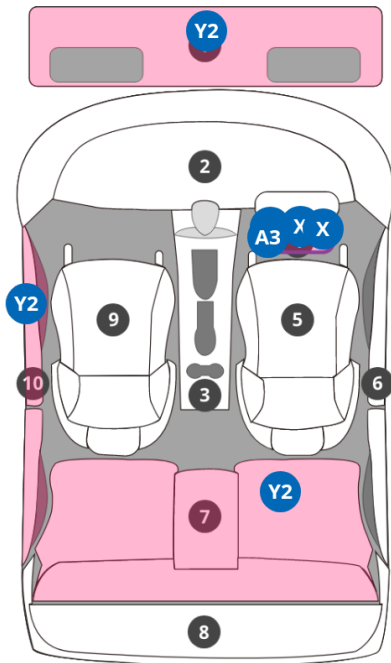
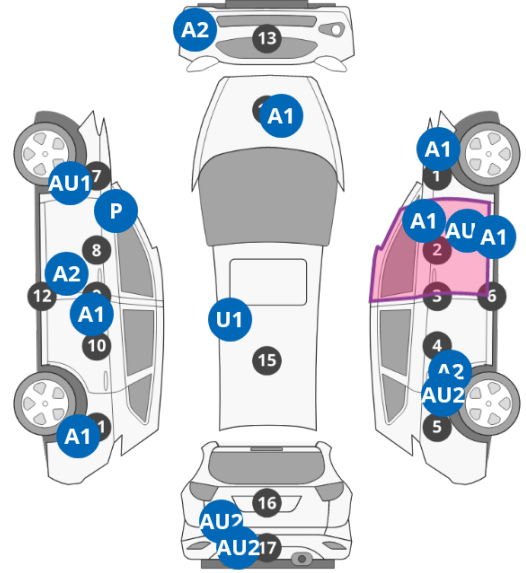
Interior Evaluation :	B	Exterior Evaluation :	C

<p>a : Cut, Fray d : Loose, Deformed k : Animal Hair s : Smell t : Cigarette Burns x : Defective y : Stain</p>		<p>A : Scratch AU : Scratch & Dent B : Modified C : Corrosion G : Stone chip P : Faded S : Rust SC : Rust & Corrosion U : Dent X : Defective Y : Crack, Gap</p>	
<p>Remarks Ceiling - Grime - Small / (R) Front Floor Mat - Missing - Yes / (L) Front Floor Mat - Missing - Yes / Mat Other - Missing - Yes / Carpet - Worn, Scratch, Cut, Crack - Medium / Rear Seat - Grime - Small / (L) Front Trim - Grime - Small</p>		<p>Remarks (R) Front Fender, Molding - Scratch - Minimal / (R) Mirror - Scratch - Minimal / (R) Front Door, Molding - Repair mark - Yes / (R) Front Door, Molding - Scratch & Dent - Minimal / (R) Step, In-panel, Side Spoiler - Scratch - Minimal / (R) Rear Door, Molding - Scratch - Small / (R) Rear Fender, Molding - Scratch & Dent - Small / Trunk Hood, Rear Gate - Scratch & Dent - Small / Rear Bumper, Lamps, Panels - Scratch & Dent - Small / (L) Rear Fender, Molding - Scratch - Minimal / (L) Rear Door, Molding - Scratch - Minimal / (L) Front Door, Molding - Scratch - Small / (L) Mirror - Faded(Color, Gloss) - Yes / (L) Front Fender, Molding - Scratch & Dent - Minimal / Bonnet, Headlight - Scratch - Minimal / Front Bumper, Grille, Lamps - Scratch - Small / Roof - Dent - Minimal</p>

Inspector Notes
With Lto plate, with spare tire and jack, 2key, no warranty booklet and tools, scratches on headlights and taillights, splash of cement on body
