General Information

Make	Toyota	Model	Wigo
YOM	2019	Odo Meter Reading	60,031
Registration No.	NDA3361	Chassis No.	MHKA4DF5FJJ024280
CC	1.0	Transmission	A/T
Fuel Type	Gas	Type of Body	Hatchback
Colour	Black

Body / Panel Condition

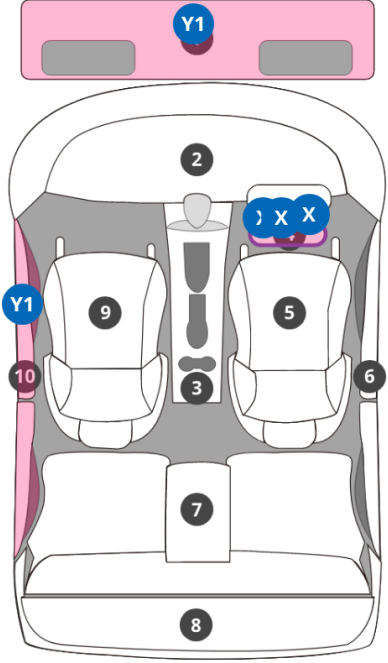
Interior Evaluation : B	Exterior Evaluation : B

<p>a : Cut, Fray d : Loose, Deformed k : Animal Hair s : Smell t : Cigarette Burns x : Defective y : Stain</p>

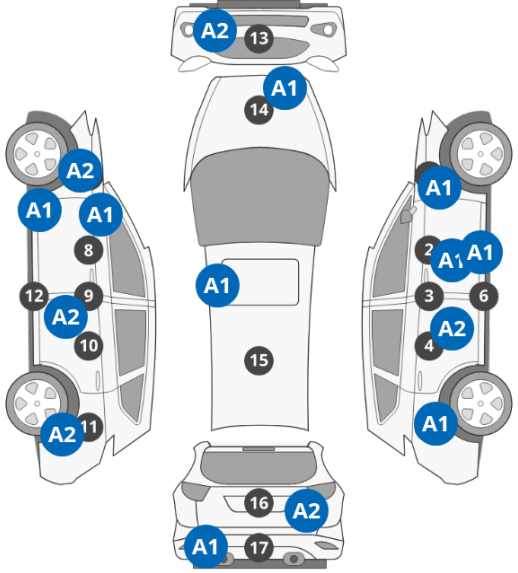
<p>A : Scratch AU : Scratch & Dent B : Modified C : Corrosion G : Stone chip P : Faded S : Rust SC : Rust & Corrosion U : Dent X : Defective Y : Crack, Gap</p>
<p>Remarks (R) Front Floor Mat - Missing - Yes / (L) Front Floor Mat - Missing - Yes / Mat Other - Missing - Yes / Ceiling - Grime - Minimal / (L) Front Trim - Grime - Minimal</p>	<p>Remarks (R) Front Fender, Molding - Scratch - Minimal / (R) Front Door, Molding - Scratch - Minimal / (R) Rear Door, Molding - Scratch - Small / (R) Step, In-panel, Side Spoiler - Scratch - Minimal / (R) Rear Fender, Molding - Scratch - Minimal / Trunk Hood, Rear Gate - Scratch - Small / Rear Bumper, Lamps, Panels - Scratch - Minimal / (L) Rear Fender, Molding - Scratch - Small / (L) Rear Door, Molding - Scratch - Small / Roof - Scratch - Minimal / (L) Mirror - Scratch - Minimal / (L) Front Door, Molding - Scratch - Minimal / (L) Front Fender, Molding - Scratch - Small / Bonnet, Headlight - Scratch - Minimal / Front Bumper, Grille, Lamps - Scratch - Small</p>

<p>Inspector Notes</p>
<p>With Lto plate, with warranty booklet, with jack, 1key, no spare tire and tools, scratches on headlights and taillights, trunk issue</p>
