## General Information

| Make | Toyota | Model | Vios |

## Body / Panel Condition

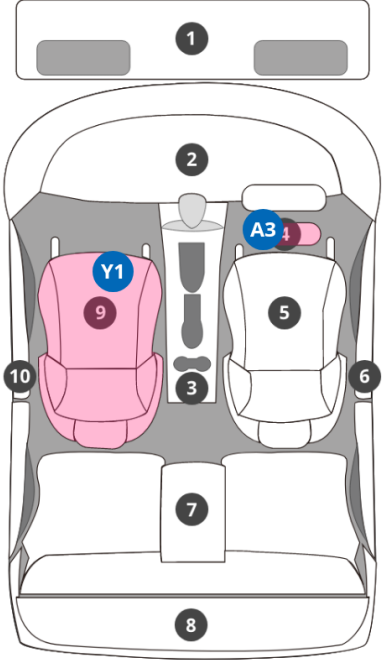
| Interior Evaluation : <b>B</b> | Exterior Evaluation : <b>C</b> |
| <b>Remarks</b><br>(L) Front Seat - Grime - Minimal / (L) Front Floor Mat - Cut, Crack - Medium | <b>Remarks</b><br>Rear Bumper, Lamps, Panels - Scratch - Large / Trunk Hood, Rear Gate - Scratch - Small / (L) Rear Fender, Molding - Scratch & Dent - Small / (L) Rear Door, Molding - Scratch - Small / (L) Front Door, Molding - Scratch - Small / Front Bumper, Grille, Lamps - Scratch - Medium / (R) Step, In-panel, Side Spoiler - Scratch & Dent - Medium / (R) Front Door, Molding - Scratch - Small / (R) Front Fender, Molding - Scratch - Minimal / Roof - Dent - Small / (R) Rear Fender, Molding - Scratch & Dent - Small |
