General Information

Make	Toyota	Model	Vios
YOM	2025	Odo Meter Reading	10,023
Registration No.	DBU6406	Chassis No.	PA1B18F35S4287065
CC	1.3	Transmission	CVT
Fuel Type	Gas	Type of Body	Sedan
Colour	Red

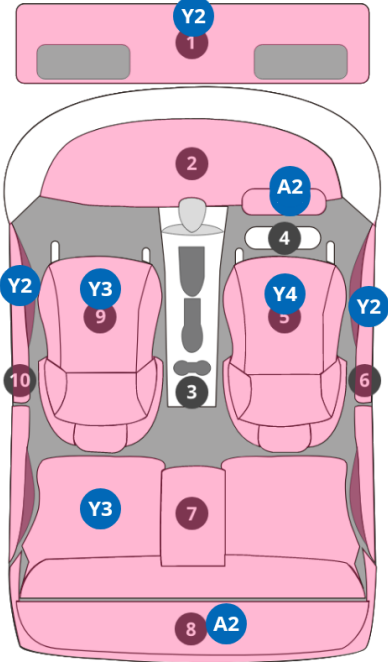
Interior Evaluation : C	Exterior Evaluation : E

<p>a : Cut, Fray d : Loose, Deformed k : Animal Hair s : Smell t : Cigarette Burns x : Defective y : Stain</p>

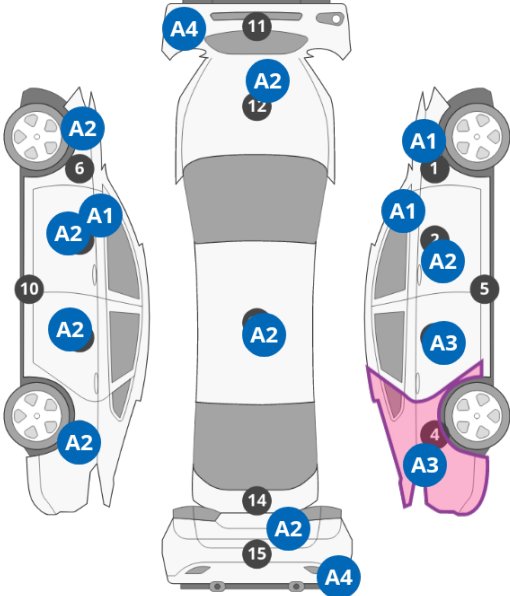
<p>A : Scratch AU : Scratch & Dent B : Modified C : Corrosion G : Stone chip P : Faded S : Rust SC : Rust & Corrosion U : Dent X : Defective Y : Crack, Gap</p>
<p>Remarks (R) Front Seat - Grime - Large / (R) Front Trim - Grime - Small / Rear Seat - Grime - Medium / Trunk Room - Worn, Scratch, Cut, Crack - Small / (L) Front Trim - Grime - Small / (L) Front Seat - Grime - Medium / Dashboard - Worn, Scratch, Cut, Crack - Small / Steering Wheel - Worn, Peel, Crack - Small / Ceiling - Grime - Small</p>	<p>Remarks (R) Rear Fender - Repair Traces - Yes / Rear Bumper, Lamps, Panels - Scratch - Large / (R) Rear Fender, Molding - Repair mark - Yes / (R) Rear Fender, Molding - Scratch - Medium / (R) Rear Door, Molding - Scratch - Medium / (R) Front Door, Molding - Scratch - Small / (R) Mirror - Scratch - Minimal / (R) Front Fender, Molding - Scratch - Minimal / Trunk Hood, Rear Gate - Scratch - Small / (L) Rear Fender, Molding - Scratch - Small / (L) Rear Door, Molding - Scratch - Small / (L) Front Door, Molding - Scratch - Small / (L) Mirror - Scratch - Minimal / (L) Front Fender, Molding - Scratch - Small / Front Bumper, Grille, Lamps - Scratch - Large / Bonnet, Headlight - Scratch - Small / Roof - Scratch - Small</p>
