## General Information

| <b>Make</b> | Toyota | <b>Model</b> | Vios |
| <b>YOM</b> | 2025 | <b>Odo Meter Reading</b> | 4,808 |
| <b>Registration No.</b> | DBU6844 | <b>Chassis No.</b> | PA1B18F30S4288124 |

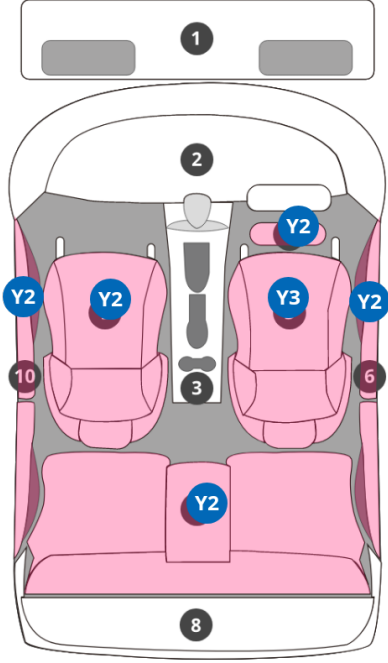
| <b>Interior Evaluation :</b> <span style="float: right;"><b>B</b></span> | <b>Exterior Evaluation :</b> <span style="float: right;"><b>C</b></span> |

| <p><b>Remarks</b><br/>Rear Seat - Grime - Small / (R) Front Seat - Grime - Medium / (R) Front Trim - Grime - Small / (L) Front Trim - Grime - Small / (L) Front Seat - Grime - Small / (L) Front Floor Mat - Grime - Small</p> | <p><b>Remarks</b><br/>Bonnet, Headlight - Scratch - Small / (R) Front Fender, Molding - Scratch - Medium / Front Bumper, Grille, Lamps - Scratch - Medium / (R) Front Door, Molding - Scratch - Small / (R) Rear Door, Molding - Scratch - Minimal / (R) Rear Fender, Molding - Scratch - Minimal / Rear Bumper, Lamps, Panels - Scratch - Small / Trunk Hood, Rear Gate - Scratch - Minimal / (L) Front Door, Molding - Scratch - Minimal / (L) Front Fender, Molding - Scratch - Minimal / (L) Rear Door, Molding - Scratch - Minimal / (L) Rear Fender, Molding - Scratch - Minimal / Roof - Scratch - Minimal</p> |
