## General Information

<b>Make</b>	Toyota	<b>Model</b>	Vios
<b>YOM</b>	2025	<b>Odo Meter Reading</b>	5,753
<b>Registration No.</b>	GBJ8527	<b>Chassis No.</b>	PA1B18F38S4288243
<b>CC</b>	1.3	<b>Transmission</b>	CVT
<b>Fuel Type</b>	Gas	<b>Type of Body</b>	Sedan
<b>Colour</b>	Silver

## Body / Panel Condition

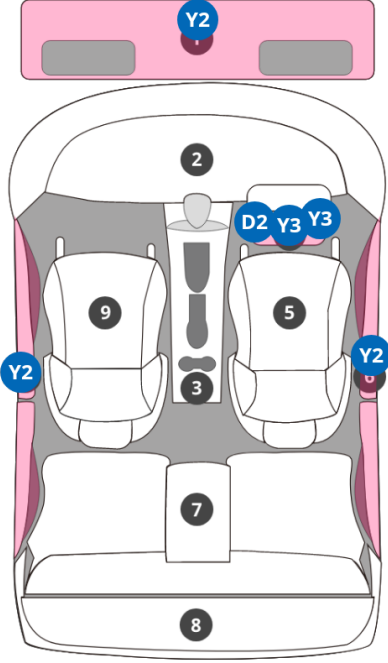
<b>Interior Evaluation :</b> <span style="float: right;"><b>B</b></span>	<b>Exterior Evaluation :</b> <span style="float: right;"><b>B</b></span>

<p><b>a</b> : Cut, Fray <b>d</b> : Loose, Deformed <b>k</b> : Animal Hair <b>s</b> : Smell <b>t</b> : Cigarette Burns <b>x</b> : Defective <b>y</b> : Stain</p>

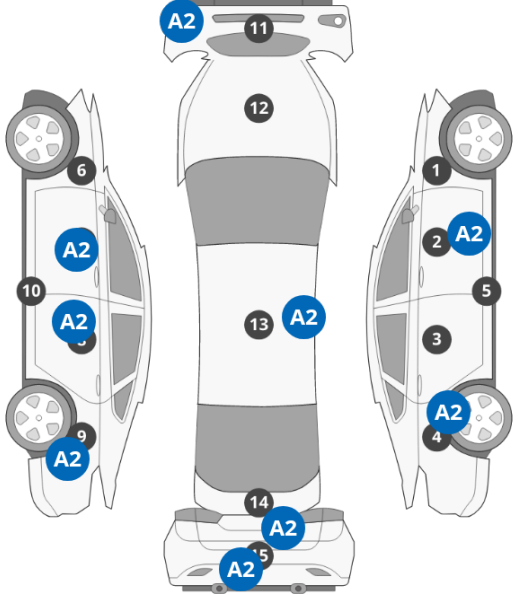
<p><b>A</b> : Scratch <b>AU</b> : Scratch &amp; Dent <b>B</b> : Modified <b>C</b> : Corrosion <b>G</b> : Stone chip <b>P</b> : Faded <b>S</b> : Rust <b>SC</b> : Rust &amp; Corrosion <b>U</b> : Dent <b>X</b> : Defective <b>Y</b> : Crack, Gap</p>
<p><b>Remarks</b> (L) Front Trim - Grime - Small / (L) Front Floor Mat - Worked - Small / Ceiling - Grime - Small / Mat Other - Grime - Medium / (R) Front Floor Mat - Grime - Medium / (R) Front Trim - Grime - Small</p>	<p><b>Remarks</b> (L) Front Door, Molding - Scratch - Small / (L) Rear Door, Molding - Scratch - Small / (L) Rear Fender, Molding - Scratch - Small / Trunk Hood, Rear Gate - Scratch - Small / Rear Bumper, Lamps, Panels - Scratch - Small / (R) Rear Fender, Molding - Scratch - Small / (R) Front Door, Molding - Scratch - Small / Roof - Scratch - Small / Front Bumper, Grille, Lamps - Scratch - Small</p>
