General Information

Make	Toyota	Model	Vios
YOM	2025	Odo Meter Reading	23,444
Registration No.	EAL1069	Chassis No.	PA1B18F34S4285100
CC	1.3	Transmission	CVT
Fuel Type	Gas	Type of Body	Sedan
Colour	Black

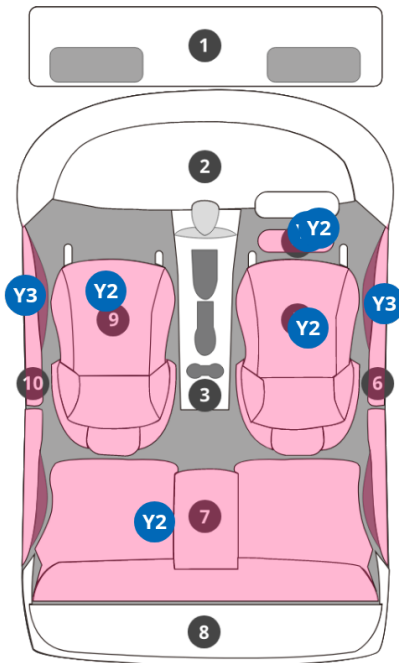
Interior Evaluation : C	Exterior Evaluation : E

<p>a : Cut, Fray d : Loose, Deformed k : Animal Hair s : Smell t : Cigarette Burns x : Defective y : Stain</p>

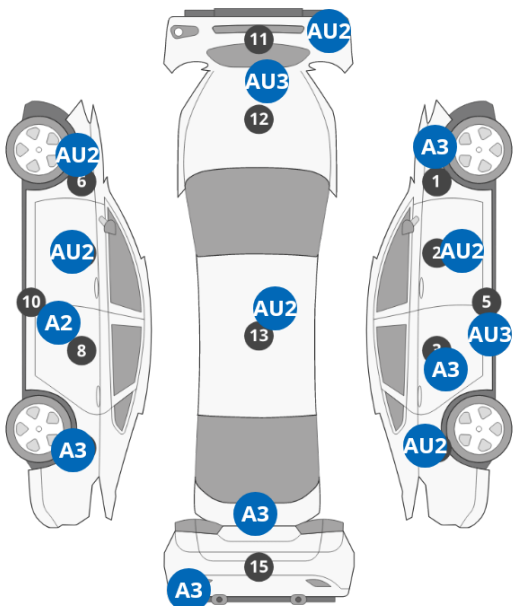
<p>A : Scratch AU : Scratch & Dent B : Modified C : Corrosion G : Stone chip P : Faded S : Rust SC : Rust & Corrosion U : Dent X : Defective Y : Crack, Gap</p>
<p>Remarks (L) Front Floor Mat - Grime - Medium / (R) Front Trim - Grime - Medium / (L) Front Trim - Grime - Medium / (R) Front Floor Mat - Grime - Small / Rear Seat - Grime - Small / (L) Front Seat - Grime - Small / (R) Front Seat - Grime - Small</p>	<p>Remarks Trunk Hood, Rear Gate - Repair Traces - Yes / Bonnet, Headlight - Scratch & Dent - Medium / Front Bumper, Grille, Lamps - Scratch & Dent - Small / (L) Front Fender, Molding - Scratch & Dent - Small / (L) Rear Door, Molding - Scratch - Small / (L) Rear Fender, Molding - Scratch - Medium / Rear Bumper, Lamps, Panels - Scratch - Medium / Trunk Hood, Rear Gate - Scratch - Medium / (R) Rear Fender, Molding - Scratch & Dent - Small / (R) Rear Door, Molding - Scratch - Medium / (R) Step, In-panel, Side Spoiler - Scratch & Dent - Medium / (R) Front Fender, Molding - Scratch - Medium / Roof - Scratch & Dent - Small / (L) Front Door, Molding - Scratch & Dent - Small / (R) Front Door, Molding - Scratch & Dent - Small</p>
