## General Information

<b>Make</b>	Toyota	<b>Model</b>	Vios
<b>YOM</b>	2025	<b>Odo Meter Reading</b>	8,935
<b>Registration No.</b>	HAH8507	<b>Chassis No.</b>	PA1B18F36S4291402
<b>CC</b>	1.3	<b>Transmission</b>	CVT
<b>Fuel Type</b>	Gas	<b>Type of Body</b>	Sedan
<b>Colour</b>	Red

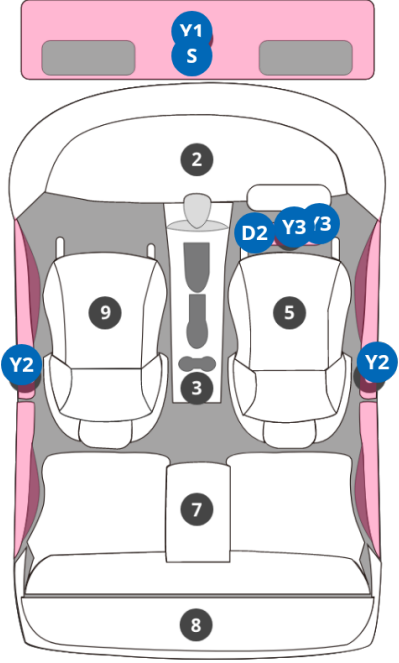
<b>Interior Evaluation :</b> <span style="float: right;"><b>B</b></span>	<b>Exterior Evaluation :</b> <span style="float: right;"><b>C</b></span>

<p><b>a</b> : Cut, Fray <b>d</b> : Loose, Deformed <b>k</b> : Animal Hair <b>s</b> : Smell <b>t</b> : Cigarette Burns <b>x</b> : Defective <b>y</b> : Stain</p>

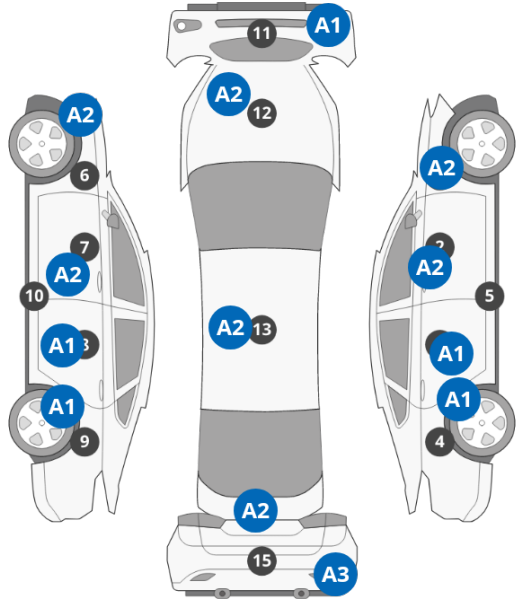
<p><b>A</b> : Scratch <b>AU</b> : Scratch &amp; Dent <b>B</b> : Modified <b>C</b> : Corrosion <b>G</b> : Stone chip <b>P</b> : Faded <b>S</b> : Rust <b>SC</b> : Rust &amp; Corrosion <b>U</b> : Dent <b>X</b> : Defective <b>Y</b> : Crack, Gap</p>
<p><b>Remarks</b> (R) Front Floor Mat - Grime - Medium / (R) Front Trim - Grime - Small / Ceiling - Grime - Minimal / Mat Other - Grime - Medium / (L) Front Trim - Grime - Small / (L) Front Floor Mat - Worked - Small / Overall Interior - Smell - Yes</p>	<p><b>Remarks</b> (L) Front Fender, Molding - Scratch - Small / (L) Front Door, Molding - Scratch - Small / (L) Rear Door, Molding - Scratch - Minimal / (L) Rear Fender, Molding - Scratch - Minimal / Trunk Hood, Rear Gate - Scratch - Small / Rear Bumper, Lamps, Panels - Scratch - Medium / (R) Rear Fender, Molding - Scratch - Minimal / (R) Rear Door, Molding - Scratch - Minimal / (R) Front Door, Molding - Scratch - Small / (R) Front Fender, Molding - Scratch - Small / Bonnet, Headlight - Scratch - Small / Front Bumper, Grille, Lamps - Scratch - Minimal / Roof - Scratch - Small</p>
