## General Information

<b>Make</b>	Toyota	<b>Model</b>	Vios
<b>YOM</b>	2025	<b>Odo Meter Reading</b>	7,946
<b>Registration No.</b>	GBK8290	<b>Chassis No.</b>	PA1B18F35S4291956
<b>CC</b>	1.3	<b>Transmission</b>	CVT
<b>Fuel Type</b>	Gas	<b>Type of Body</b>	Sedan
<b>Colour</b>	Blue

## Body / Panel Condition

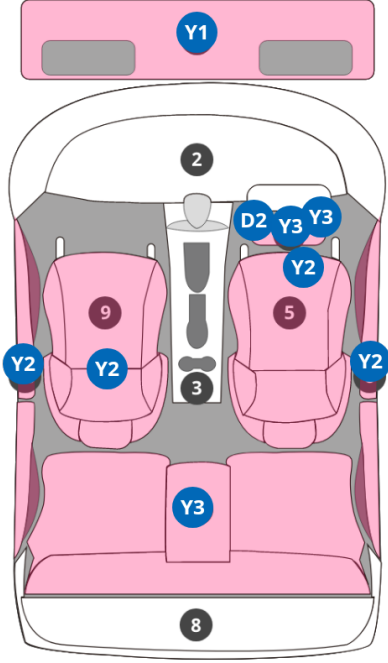
<b>Interior Evaluation :</b> <span style="color: red; font-weight: bold;">C</span>	<b>Exterior Evaluation :</b> <span style="color: red; font-weight: bold;">C</span>

<p><b>A</b> : Scratch <b>AU</b> : Scratch &amp; Dent <b>B</b> : Modified <b>C</b> : Corrosion <b>G</b> : Stone chip <b>P</b> : Faded <b>S</b> : Rust <b>SC</b> : Rust &amp; Corrosion <b>U</b> : Dent <b>X</b> : Defective <b>Y</b> : Crack, Gap</p>
<p><b>Remarks</b> (L) Front Seat - Grime - Small / (L) Front Floor Mat - Worked - Small / (L) Front Trim - Grime - Small / Ceiling - Grime - Minimal / Mat Other - Grime - Medium / Rear Seat - Grime - Medium / (R) Front Trim - Grime - Small / (R) Front Seat - Grime - Small / (R) Front Floor Mat - Grime - Medium</p>	<p><b>Remarks</b> (L) Front Fender, Molding - Scratch - Minimal / (L) Front Door, Molding - Scratch &amp; Dent - Large / (L) Rear Door, Molding - Scratch - Small / (L) Rear Fender, Molding - Scratch - Minimal / Trunk Hood, Rear Gate - Scratch - Minimal / Rear Bumper, Lamps, Panels - Scratch - Small / (R) Rear Door, Molding - Scratch - Minimal / (R) Front Door, Molding - Scratch - Small / Roof - Scratch - Minimal / Bonnet, Headlight - Scratch - Small / Front Bumper, Grille, Lamps - Scratch - Small</p>
