## General Information

| Make | Toyota | Model | Vios |

## Body / Panel Condition

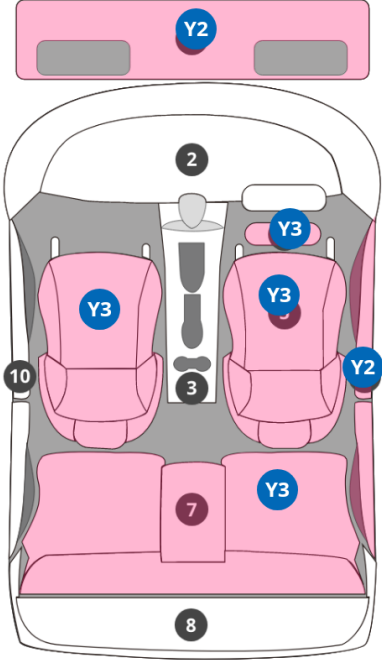
| Interior Evaluation : <span style="color: red;">C</span> | Exterior Evaluation : <span style="color: red;">C</span> |
|---|---|
| <p><b>Remarks</b><br/>(R) Front Trim - Grime - Small / (R) Front Seat - Grime - Medium / Rear Seat - Grime - Medium / Mat Other - Grime - Medium / (L) Front Seat - Grime - Medium / Ceiling - Grime - Small</p> | <p><b>Remarks</b><br/>(R) Front Door, Molding - Scratch &amp; Dent - Small / (R) Rear Door, Molding - Scratch - Small / (R) Step, In-panel, Side Spoiler - Scratch - Small / (R) Rear Fender, Molding - Scratch - Small / Rear Bumper, Lamps, Panels - Scratch - Medium / (L) Rear Fender, Molding - Scratch - Minimal / (L) Front Door, Molding - Scratch - Minimal / (L) Front Fender, Molding - Scratch - Medium / Front Bumper, Grille, Lamps - Scratch &amp; Dent - Small / Trunk Hood, Rear Gate - Scratch &amp; Dent - Small</p> |
