General Information

Make	Toyota	Model	Avanza
YOM	2024	Odo Meter Reading	14,364
Registration No.	NFR1073	Chassis No.	MHFAA1BY1R0023380
CC	1.3	Transmission	CVT
Fuel Type	Gas	Type of Body	MPV
Colour	Silver

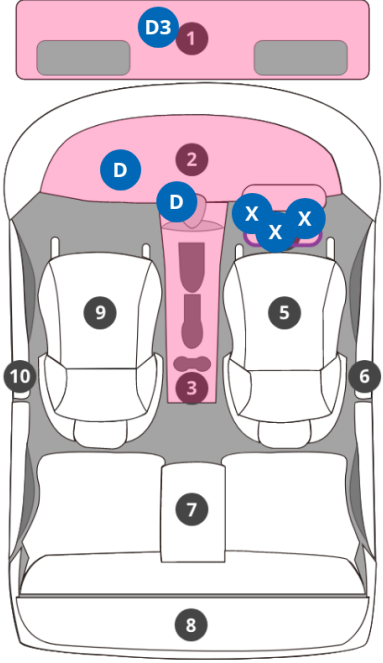
Interior Evaluation : B	Exterior Evaluation : C

<p>a : Cut, Fray d : Loose, Deformed k : Animal Hair s : Smell t : Cigarette Burns x : Defective y : Stain</p>

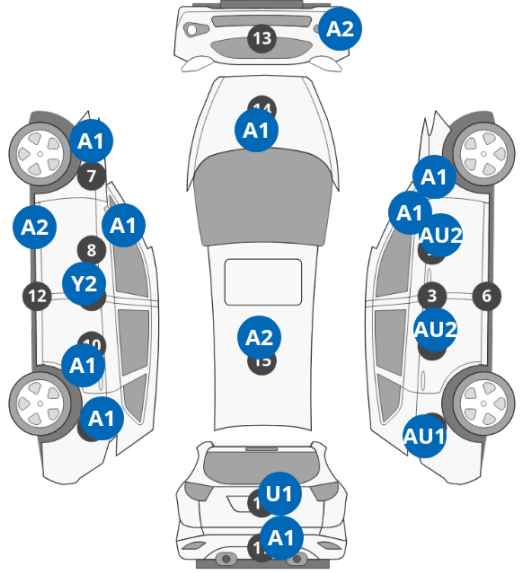
<p>A : Scratch AU : Scratch & Dent B : Modified C : Corrosion G : Stone chip P : Faded S : Rust SC : Rust & Corrosion U : Dent X : Defective Y : Crack, Gap</p>
<p>Remarks Ceiling - Crinkle - Medium / (R) Front Floor Mat - Missing - Yes / Mat Other - Missing - Yes / (L) Front Floor Mat - Missing - Yes / Console, Switchs, Vents - Traces of Adhesive Tape - Yes / Dashboard - Traces of Adhesive Tape - Yes</p>	<p>Remarks (R) Mirror - Scratch - Minimal / (R) Front Fender, Molding - Scratch - Minimal / (R) Front Door, Molding - Scratch & Dent - Small / (R) Rear Door, Molding - Scratch & Dent - Small / (R) Rear Fender, Molding - Scratch & Dent - Minimal / Rear Bumper, Lamps, Panels - Scratch - Minimal / Trunk Hood, Rear Gate - Dent - Minimal / (L) Rear Fender, Molding - Scratch - Minimal / (L) Rear Door, Molding - Scratch - Minimal / (L) Step, In-panel, Side Spoiler - Scratch - Small / (L) Mirror - Scratch - Minimal / (L) Front Fender, Molding - Scratch - Minimal / Front Bumper, Grille, Lamps - Scratch - Small / Bonnet, Headlight - Scratch - Minimal / Roof - Scratch - Small / (L) Front Door, Molding - Crack, Gap - Small</p>
