General Information

Make	Toyota	Model	Vios
YOM	2024	Odo Meter Reading	10,474
Registration No.	NFR3821	Chassis No.	PA1B18F35R4251841
CC	1.3	Transmission	CVT
Fuel Type	Gas	Type of Body	Sedan
Colour	Blue

Body / Panel Condition

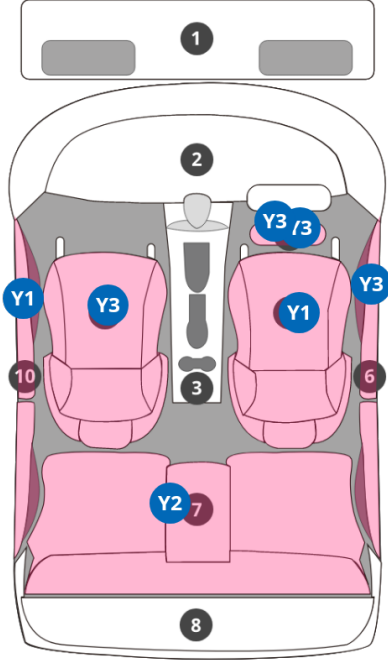
Interior Evaluation : C	Exterior Evaluation : C

<p>a : Cut, Fray d : Loose, Deformed k : Animal Hair s : Smell t : Cigarette Burns x : Defective y : Stain</p>

<p>A : Scratch AU : Scratch & Dent B : Modified C : Corrosion G : Stone chip P : Faded S : Rust SC : Rust & Corrosion U : Dent X : Defective Y : Crack, Gap</p>
<p>Remarks (R) Front Floor Mat - Grime - Medium / (L) Front Floor Mat - Grime - Medium / (L) Front Seat - Grime - Medium / (R) Front Trim - Grime - Medium / (L) Front Trim - Grime - Minimal / (R) Front Seat - Grime - Minimal / Rear Seat - Grime - Small</p>	<p>Remarks (L) Front Fender, Molding - Scratch - Small / (R) Front Fender, Molding - Scratch - Small / (R) Front Door, Molding - Scratch & Dent - Minimal / Roof - Scratch & Dent - Minimal / (R) Front Fender, Molding - Scratch & Dent - Small / (R) Rear Door, Molding - Scratch & Dent - Small / Trunk Hood, Rear Gate - Scratch & Dent - Minimal / Rear Bumper, Lamps, Panels - Scratch - Small / (L) Rear Fender, Molding - Scratch & Dent - Small / (L) Rear Door, Molding - Scratch & Dent - Minimal / (L) Step, In-panel, Side Spoiler - Scratch - Small / (R) Step, In-panel, Side Spoiler - Scratch - Small / (L) Front Door, Molding - Scratch & Dent - Minimal / Bonnet, Headlight - Scratch & Dent - Small / Front Bumper, Grille, Lamps - Scratch - Medium</p>

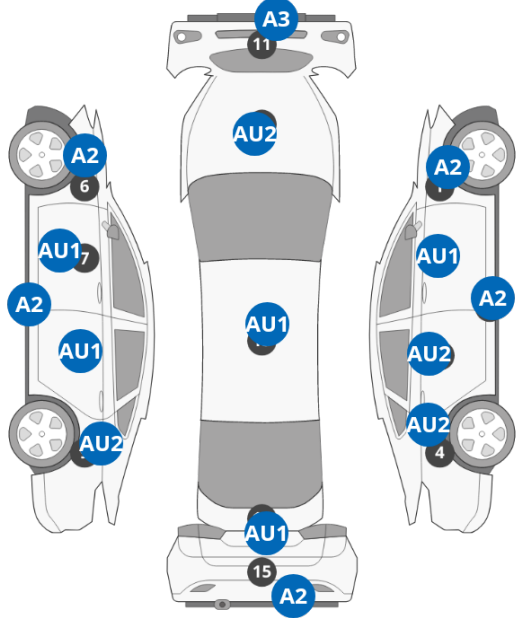
<p>Inspector Notes</p>
<p>with LTO plate, with spare tire, with tools, with manual and warranty booklet, with reverse camera, scratches on taillight and headlight, no spare key</p>
