## General Information

<b>Make</b>	Toyota	<b>Model</b>	Wigo
<b>YOM</b>	2025	<b>Odo Meter Reading</b>	8,034
<b>Registration No.</b>	GBJ6972	<b>Chassis No.</b>	MHKAA1BC2SJ037925
<b>CC</b>	1.0	<b>Transmission</b>	CVT
<b>Fuel Type</b>	Gas	<b>Type of Body</b>	Hatchback
<b>Colour</b>	Gray

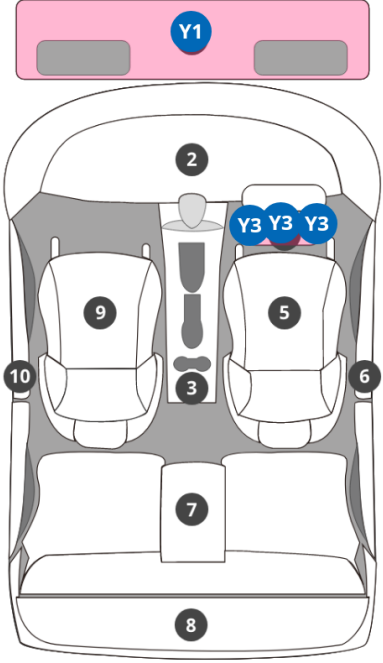
<b>Interior Evaluation :</b> <span style="float: right; color: red; font-weight: bold;">B</span>	<b>Exterior Evaluation :</b> <span style="float: right; color: red; font-weight: bold;">D</span>

<p><b>a</b> : Cut, Fray <b>d</b> : Loose, Deformed <b>k</b> : Animal Hair <b>s</b> : Smell <b>t</b> : Cigarette Burns <b>x</b> : Defective <b>y</b> : Stain</p>

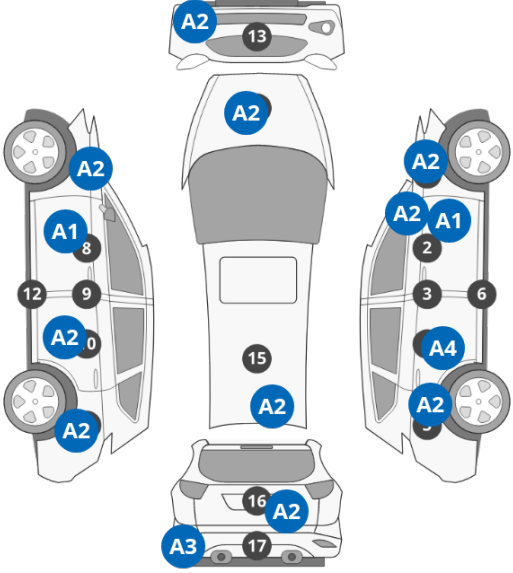
<p><b>A</b> : Scratch <b>AU</b> : Scratch &amp; Dent <b>B</b> : Modified <b>C</b> : Corrosion <b>G</b> : Stone chip <b>P</b> : Faded <b>S</b> : Rust <b>SC</b> : Rust &amp; Corrosion <b>U</b> : Dent <b>X</b> : Defective <b>Y</b> : Crack, Gap</p>
<p><b>Remarks</b> (L) Front Floor Mat - Grime - Medium / Ceiling - Grime - Minimal / Mat Other - Grime - Medium / (R) Front Floor Mat - Grime - Medium</p>	<p><b>Remarks</b> Bonnet, Headlight - Scratch - Small / (R) Front Fender, Molding - Scratch - Small / Front Bumper, Grille, Lamps - Scratch - Small / (L) Front Fender, Molding - Scratch - Small / (L) Front Door, Molding - Scratch - Minimal / (L) Rear Door, Molding - Scratch - Small / (L) Rear Fender, Molding - Scratch - Small / Trunk Hood, Rear Gate - Scratch - Small / Rear Bumper, Lamps, Panels - Scratch - Medium / (R) Rear Fender, Molding - Scratch - Small / (R) Rear Door, Molding - Scratch - Large / (R) Mirror - Scratch - Small / (R) Front Door, Molding - Scratch - Minimal / Roof Spoiler, Molding - Scratch - Small</p>
