General Information

Make	Toyota	Model	Wigo
YOM	2023	Odo Meter Reading	77,931
Registration No.	GAP1744	Chassis No.	MHKA4DE5FNJ017742
CC	1.0	Transmission	M/T
Fuel Type	Gas	Type of Body	Hatchback
Colour	Silver

Body / Panel Condition

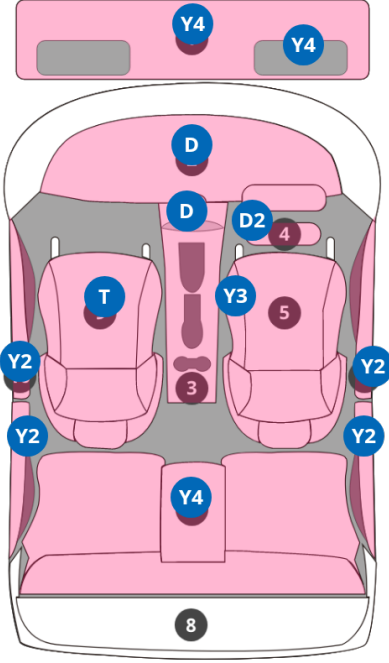
Interior Evaluation : E	Exterior Evaluation : E

<p>a : Cut, Fray d : Loose, Deformed k : Animal Hair s : Smell t : Cigarette Burns x : Defective y : Stain</p>

<p>A : Scratch AU : Scratch & Dent B : Modified C : Corrosion G : Stone chip P : Faded S : Rust SC : Rust & Corrosion U : Dent X : Defective Y : Crack, Gap</p>
<p>Remarks (R) Front Trim - Grime - Small / Dashboard - Traces of Adhesive Tape - Yes / Console, Switchs, Vents - Traces of Adhesive Tape - Yes / (R) Front Seat - Grime - Medium / Rear Seat - Grime - Large / Ceiling - Grime - Large / (L) Rear Trim - Grime - Small / (R) Rear Trim - Grime - Small / (L) Front Trim - Grime - Small / (L) Front Seat - Cigarette Burns - Burnt / (L) Front Floor Mat - Worked - Small / Sunvisor, Sunglass Holder - Grime - Large</p>	<p>Remarks (R) Front Door - Repair Traces - Yes / (R) Step - Repair Traces - Yes / (R) Front Fender - Repair Traces - Yes / Bonnet - Repair Traces - Yes / (L) Front Door - Repair Traces - Yes / (L) Step - Repair Traces - Yes / (L) Rear Door - Repair Traces - Yes / Trunk Hood, Rear Gate - Repair Traces - Yes / (R) Rear Door - Repair Traces - Yes / Roof - Repair Traces - Yes / (L) Mirror - Scratch - Small / Front Bumper, Grille, Lamps - Scratch & Dent - Large / (L) Front Fender, Molding - Scratch - Small / (L) Front Door, Molding - Scratch - Small / (L) Rear Door, Molding - Scratch - Small / (L) Rear Fender, Molding - Scratch - Small / Trunk Hood, Rear Gate - Scratch - Small / Rear Bumper, Lamps, Panels - Scratch & Dent - Large / (R) Rear Fender, Molding - Scratch - Small / (R) Rear Door, Molding - Scratch - Large / (R) Step, In-panel, Side Spoiler - Scratch - Small / (R) Front Door, Molding - Scratch - Medium / (R) Mirror - Scratch - Small / (R) Front Fender, Molding - Scratch & Dent - Small / Bonnet, Headlight - Scratch - Small / Roof - Scratch - Small</p>

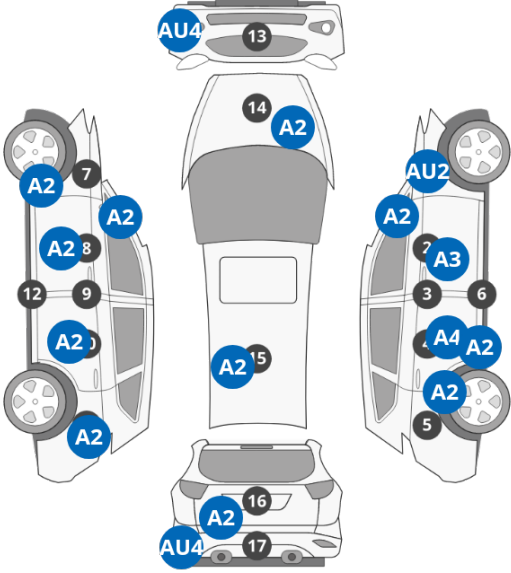
<p>Inspector Notes</p>
<p>Possible flooding. Right side mirror loose. Power folding side mirror issue. Rear seat loose. Crack left tail light. Right foglight assembly missing. Scratches at taillight. Gap at front and rear bumper. Aircon issue. Without warranty booklet, jack, tools and seat cover. With spare tire. 1 key. No LTO plate.</p>
