General Information

Make	Ford	Model	Fiesta
YOM	2017	Odo Meter Reading	50,563
Registration No.	FAC2022	Chassis No.	MPB8XXMXJ8HM80146
CC	1.6	Transmission	A/T
Fuel Type	Gas	Type of Body	Hatchback
Colour	Red

Body / Panel Condition

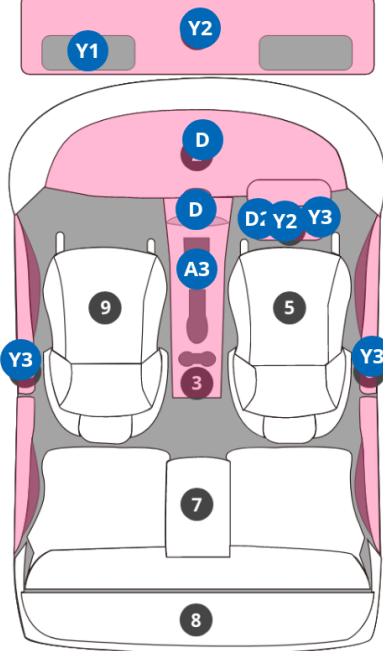
Interior Evaluation : C	Exterior Evaluation : E

<p>a : Cut, Fray d : Loose, Deformed k : Animal Hair s : Smell t : Cigarette Burns x : Defective y : Stain</p>

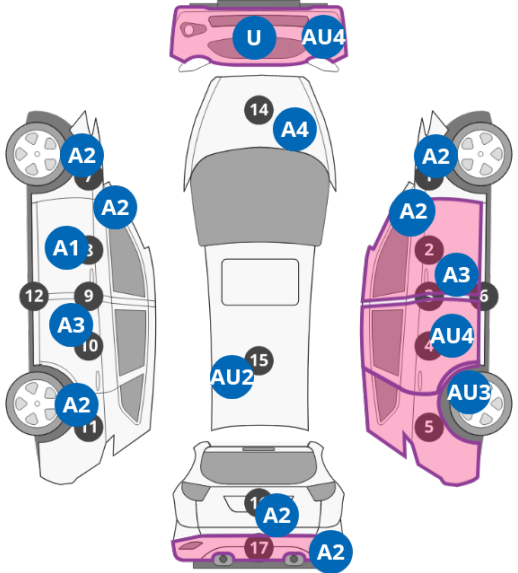
<p>A : Scratch AU : Scratch & Dent B : Modified C : Corrosion G : Stone chip P : Faded S : Rust SC : Rust & Corrosion U : Dent X : Defective Y : Crack, Gap</p>
<p>Remarks (L) Front Trim - Grime - Medium / (L) Front Floor Mat - Worked - Small / Dashboard - Traces of Adhesive Tape - Yes / Sunvisor, Sunglass Holder - Grime - Minimal / Mat Other - Grime - Small / (R) Front Trim - Grime - Medium / (R) Front Floor Mat - Grime - Medium / Knobs - Worn, Peel, Crack - Medium / Ceiling - Grime - Small / Console, Switchs, Vents - Traces of Adhesive Tape - Yes</p>	<p>Remarks (R) Front Door - Repair Traces - Yes / (R) Step - Repair Traces - Yes / (R) Rear Fender - Repair Traces - Yes / (L) Mirror - Scratch - Small / (R) Front Door, Molding - Repair mark - Yes / (R) Rear Fender, Molding - Repair mark - Yes / (L) Front Fender, Molding - Scratch - Small / (L) Front Door, Molding - Scratch - Minimal / (L) Rear Door, Molding - Scratch - Medium / (L) Rear Fender, Molding - Scratch - Small / Trunk Hood, Rear Gate - Scratch - Small / Overall Exterior - Faded(Color, Gloss) - Yes / Rear Bumper, Lamps, Panels - Repair mark - Yes / Rear Bumper, Lamps, Panels - Scratch - Small / (R) Rear Fender, Molding - Scratch & Dent - Medium / (R) Rear Door, Molding - Repair mark - Yes / (R) Rear Door, Molding - Scratch & Dent - Large / (R) Front Door, Molding - Scratch - Medium / (R) Mirror - Faded(Color, Gloss) - Yes / (R) Mirror - Scratch - Small / (R) Front Fender, Molding - Scratch - Small / Member (Bolted) - Dent - Yes / Front Bumper, Grille, Lamps - Repair mark - Yes / Front Bumper, Grille, Lamps - Scratch & Dent - Large / Bonnet, Headlight - Scratch - Large / Roof - Scratch & Dent - Small</p>
