General Information

Make	Toyota	Model	Vios
YOM	2024	Odo Meter Reading	13,928
Registration No.	NHR1513	Chassis No.	PA1B18F31P4227503
CC	1.3	Transmission	CVT
Fuel Type	Gas	Type of Body	Sedan
Colour	Black

Body / Panel Condition

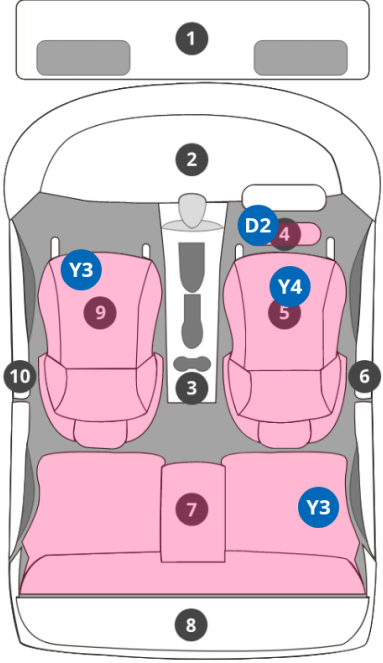
<p>a : Cut, Fray d : Loose, Deformed k : Animal Hair s : Smell t : Cigarette Burns x : Defective y : Stain</p>

<p>A : Scratch AU : Scratch & Dent B : Modified C : Corrosion G : Stone chip P : Faded S : Rust SC : Rust & Corrosion U : Dent X : Defective Y : Crack, Gap</p>
<p>Remarks Rear Seat - Grime - Medium / (R) Front Seat - Grime - Large / (L) Front Seat - Grime - Medium / (L) Front Floor Mat - Worked - Small</p>	<p>Remarks (R) Front Fender, Molding - Scratch - Medium / Front Bumper, Grille, Lamps - Scratch & Dent - Large / (L) Front Fender, Molding - Scratch & Dent - Medium / Bonnet, Headlight - Scratch & Dent - Large / (L) Rear Door, Molding - Scratch - Medium / (L) Rear Fender, Molding - Scratch & Dent - Large / Rear Bumper, Lamps, Panels - Modified - Small / Rear Bumper, Lamps, Panels - Scratch & Dent - Large / Trunk Hood, Rear Gate - Scratch - Large / (R) Front Door, Molding - Scratch - Medium / (R) Rear Door, Molding - Scratch - Large / (R) Rear Fender, Molding - Scratch - Medium</p>
