General Information

| Make | Toyota | Model | Vios |
| YOM | 2024 | Odo Meter Reading | 44,071 |

Body / Panel Condition

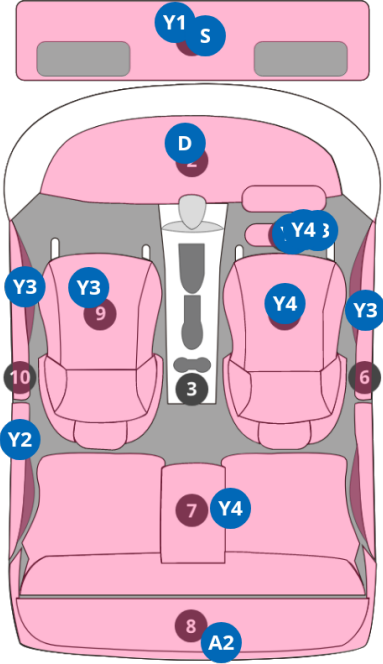
| Interior Evaluation : E | Exterior Evaluation : E |
| <p>Remarks (R) Front Trim - Grime - Medium / (R) Front Seat - Grime - Large / (R) Front Floor Mat - Grime - Large / Rear Seat - Grime - Large / Mat Other - Grime - Medium / Trunk Room - Worn, Scratch, Cut, Crack - Small / (L) Rear Trim - Grime - Small / (L) Front Trim - Grime - Medium / (L) Front Seat - Grime - Medium / (L) Front Floor Mat - Grime - Large / Dashboard - Traces of Adhesive Tape - Yes / Ceiling - Grime - Minimal / Overall Interior - Smell - Yes</p> | <p>Remarks (R) Front Door - Repair Traces - Yes / (R) Front Fender - Repair Traces - Yes / Bonnet - Repair Traces - Yes / (L) Front Fender - Repair Traces - Yes / (L) Front Door - Repair Traces - Yes / (L) Rear Door - Repair Traces - Yes / (L) Rear Fender - Repair Traces - Yes / Trunk Hood, Rear Gate - Repair Traces - Yes / (R) Rear Fender - Repair Traces - Yes / (R) Rear Door - Repair Traces - Yes / Roof - Repair Traces - Yes / Member (Bolted) - Dent - Yes / (L) Mirror - Scratch - Small / (L) Front Fender, Molding - Scratch - Medium / (L) Front Door, Molding - Scratch - Large / (L) Rear Door, Molding - Scratch - Large / (L) Step, In-panel, Side Spoiler - Scratch - Small / (L) Rear Fender, Molding - Scratch - Medium / Rear Bumper, Lamps, Panels - Scratch - Large / Trunk Hood, Rear Gate - Scratch & Dent - Small / (R) Rear Fender, Molding - Repair mark - Yes / (R) Rear Door, Molding - Repair mark - Yes / (R) Front Door, Molding - Repair mark - Yes / (R) Rear Fender, Molding - Scratch & Dent - Large / (R) Rear Door, Molding - Scratch & Dent - Large / (R) Front Door, Molding - Scratch - Large / (R) Step, In-panel, Side Spoiler - Scratch & Dent - Large / (R) Mirror - Scratch - Small / (R) Front Fender, Molding - Scratch - Medium / Front Bumper, Grille, Lamps - Crack, Gap - Large / Bonnet, Headlight - Scratch & Dent - Medium / Roof - Scratch - Medium</p> |
